Box repair and surveys

General repair procedures

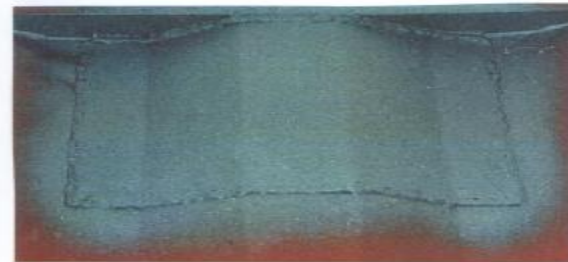
Photo 2.1 / Abrasive blasting of panel patch before priming

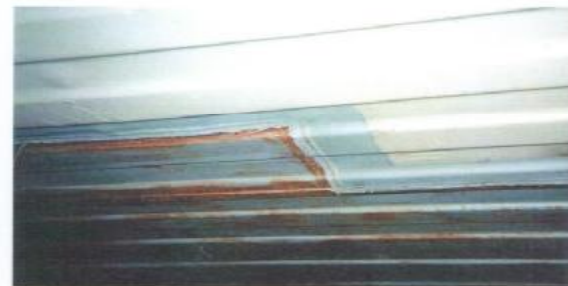
Photo 2.2 / Corrosion due to improper surface preparation of roof panel patch

Photo 4.12 Surface corrosion due to improper surface preparation and painting of a panel patch (interior view). The degree of corrosion does not require repair by itself, although the condition still may be repair-worthy depending on the owner's policy on correcting improper repairs of this type.

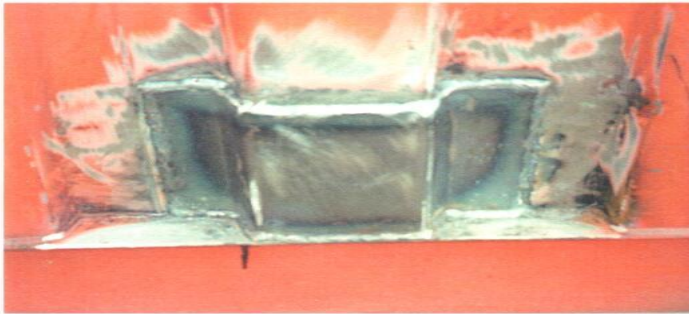
Photo 2.3 / Preparation of a panel patch by grinding and wire-brushing (note clean, bright weld condition)

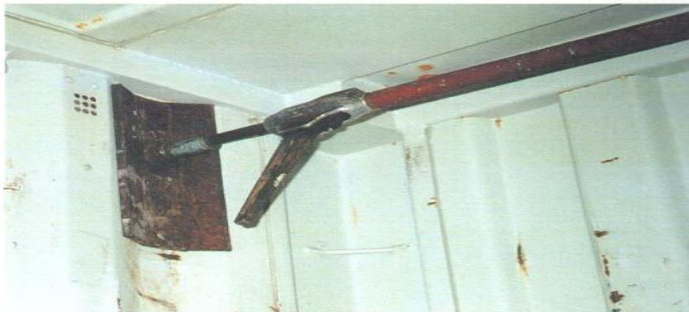
Photo 2.4 / Using a jack with a backing plate to straighten a side panel

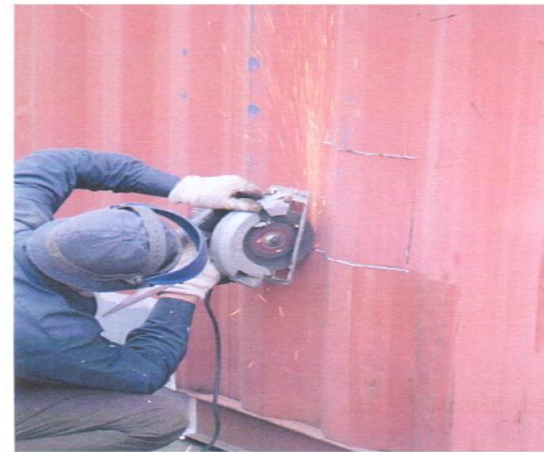
Photo 2.5 / Removing a portion of panel using a disc cutter (disc grinder)

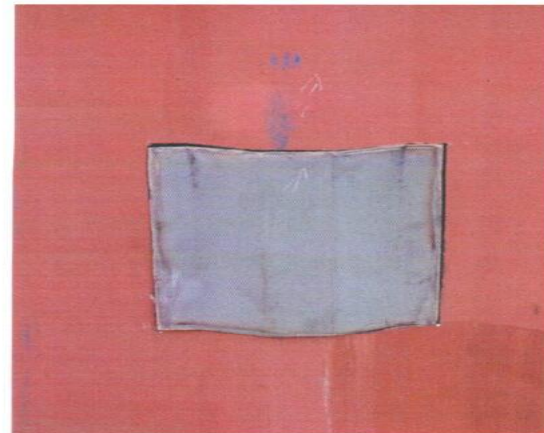
Photo 2.6 / Panel insert fitted into place (before welding)

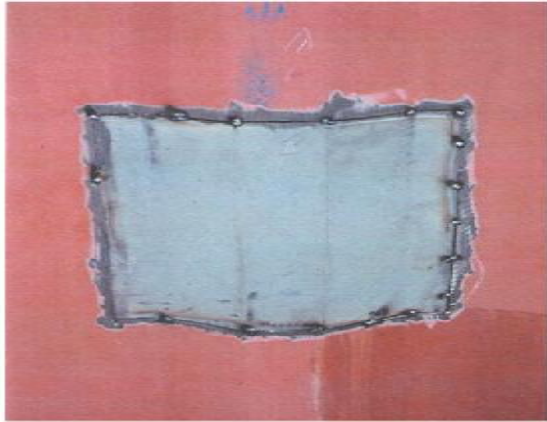
Photo 2.7 / Panel insert tack welded in position

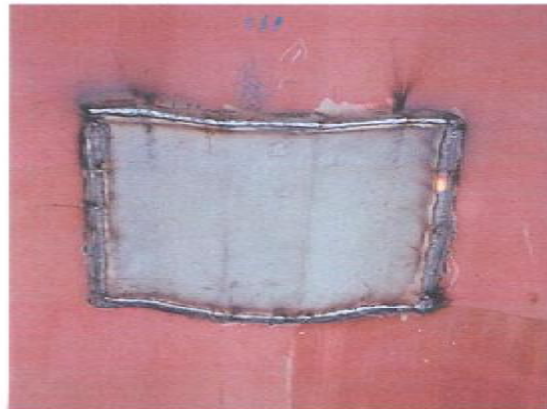
Photo 2.8 / Panel insert continuously welded

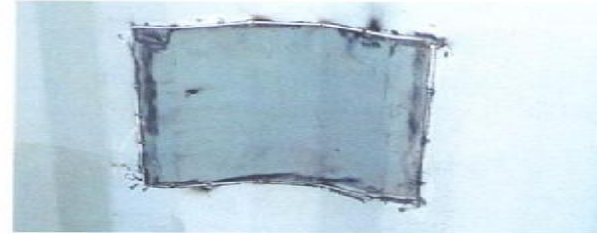
Photo 2.9 / Full penetration of continuous panel insert weld to interior side

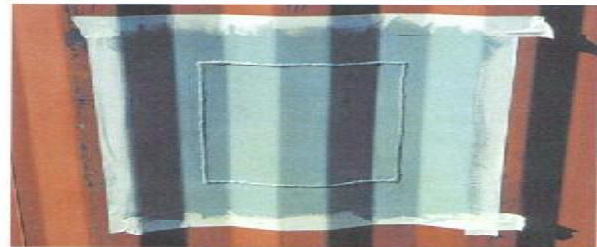
Photo 2.10 / Masking and priming of panel insert repair

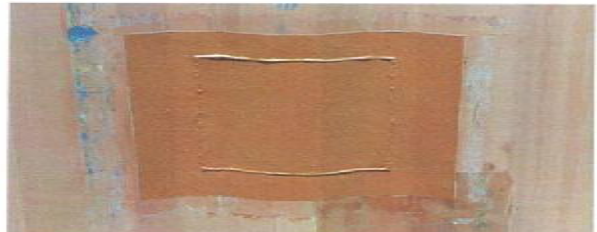
Photo 2.11 / Completed panel insert repair, fully top coated

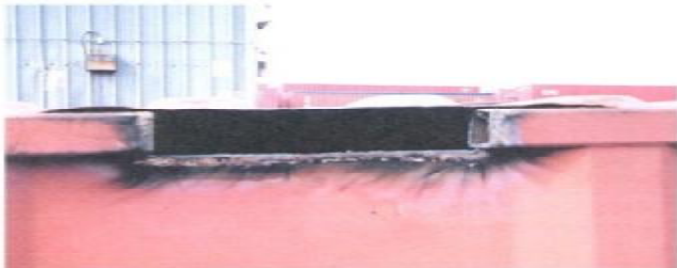
Photo 2.12 / Damaged top side rail area removed before installing a new section. Note that the roof panel has been detached beyond the edges of the removed area, and the edges of rail have been beveled.

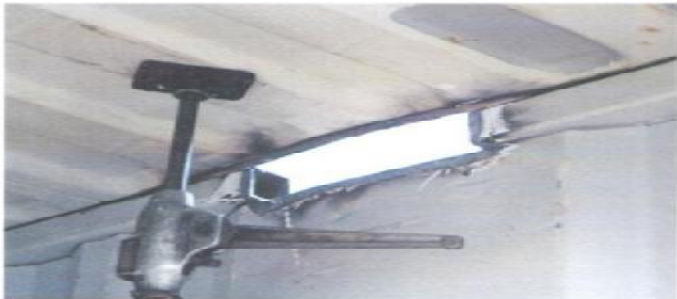
Photo 2.13 / Jacking up of roof sheet to provide clearance for removal of damaged material and rewelding of top side rail section

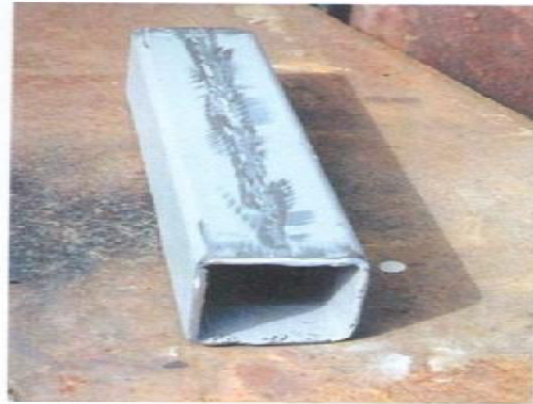
Photo 2.14 / Tube-type top side rail section cut to size, cleaned and beveled

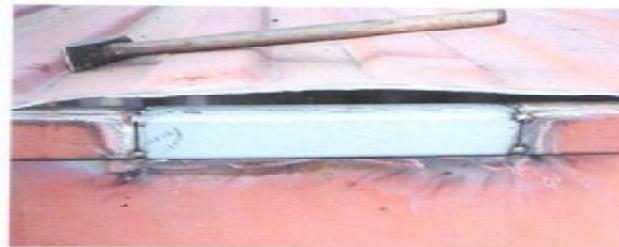
Photo 2.15 / Tube-type top side rail section tack-welded into position

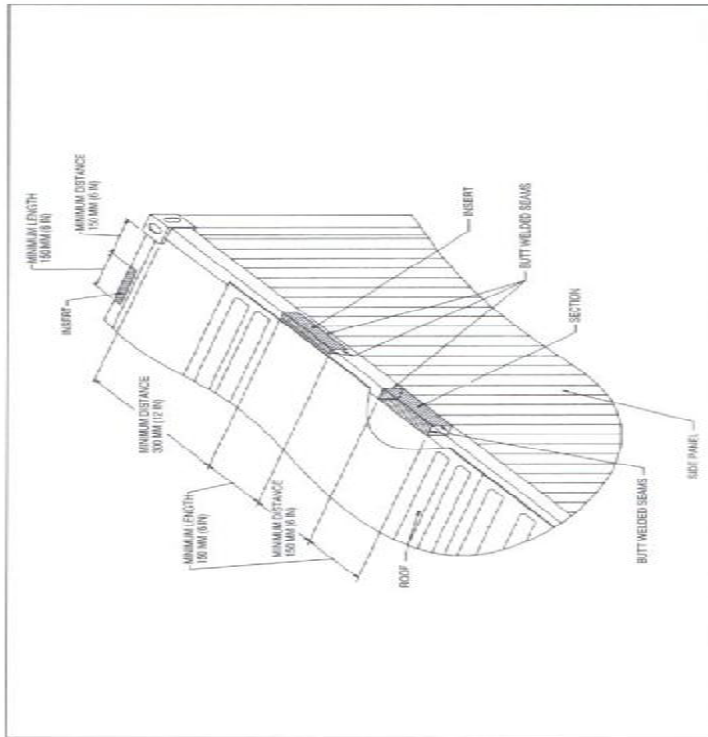
Fig. 5.1/Top rail insert and section limitations

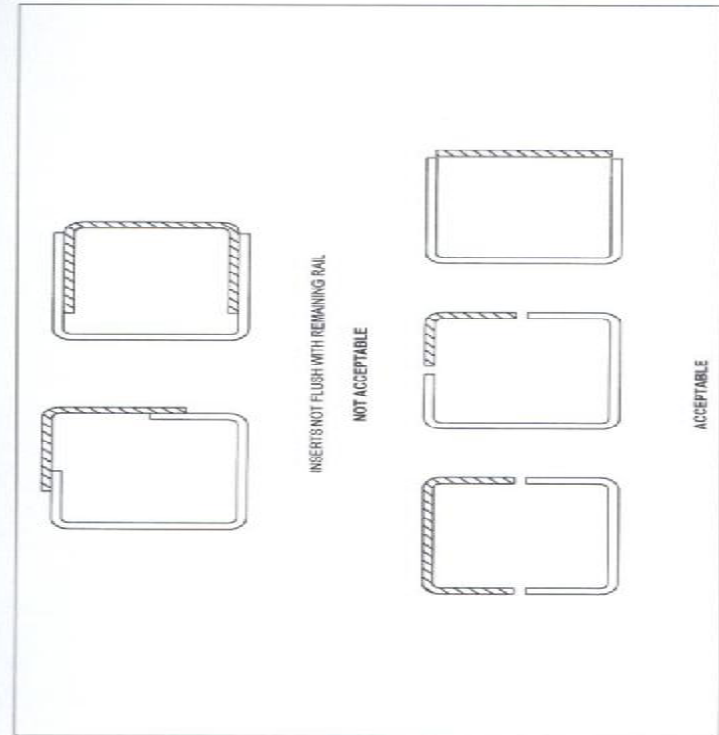
Fig. 5.2/Cross sections of top rail inserts (before welding)

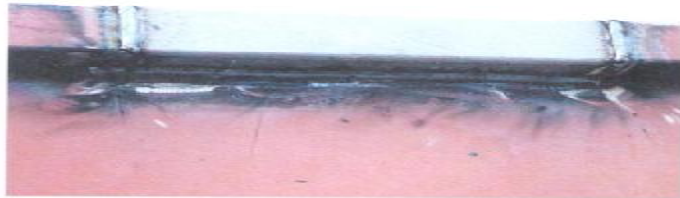
Photo 2.16 / Tube-type top side rail section continuously welded (exterior view)

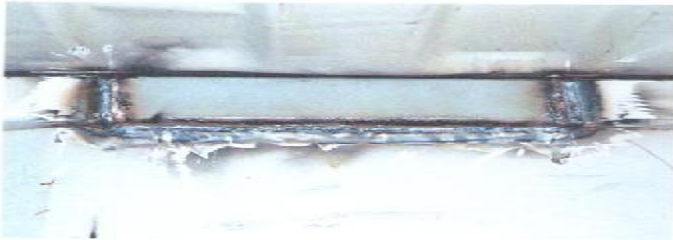
Photo 2.17 / Tube-type top side rail section continuously welded (interior view)

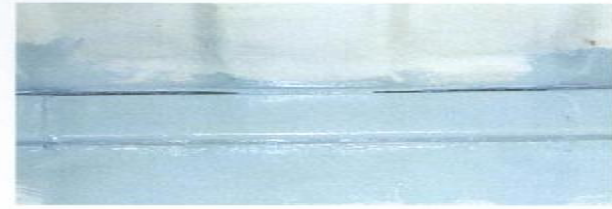
Photo 2.18 / Priming of tube-type top side rail section and adjacent surfaces on the interior.
NOTE: For a neater finished appearance after painting, mask a rectangle around the area to be primed and top coated before paint is applied.

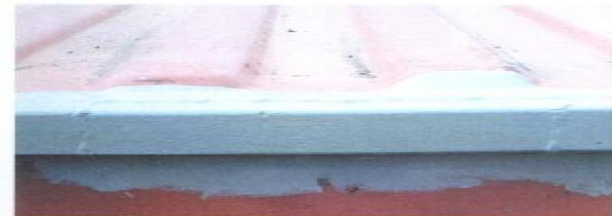
Photo 2.19 / Priming of tube-type top side rail section and adjacent surfaces on the exterior.
See note above for Photo 2.18.

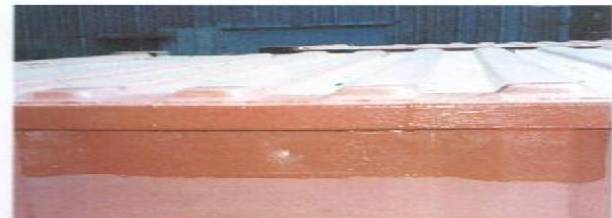
Photo 2.20 / Top-coating of tube-type top side rail section and adjacent surfaces on the exterior.
See note above for Photo 2.18.

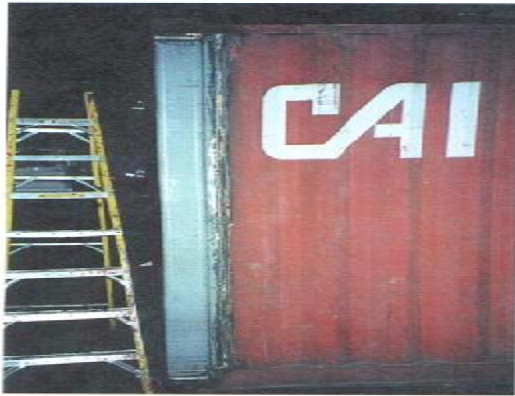
Photo 2.25 / Front corner post continuously welded in place

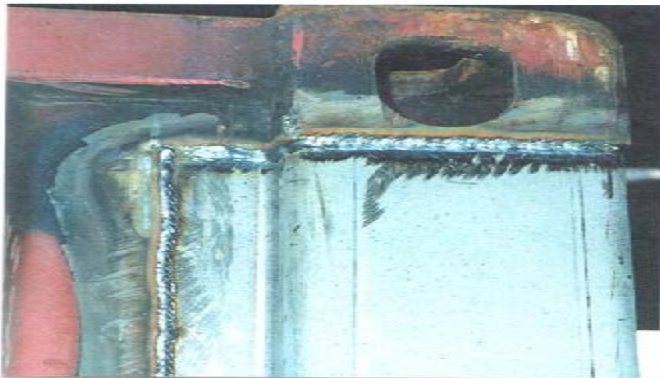
Photo 2.26 / Detail of front corner post welding adjacent to corner fitting

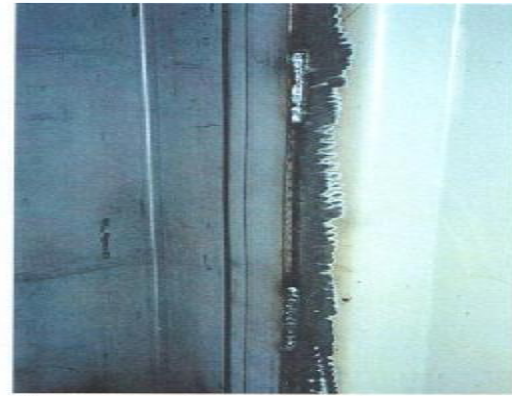
Photo 2.27 / Skip welding of interior of corner post/panel lap joint

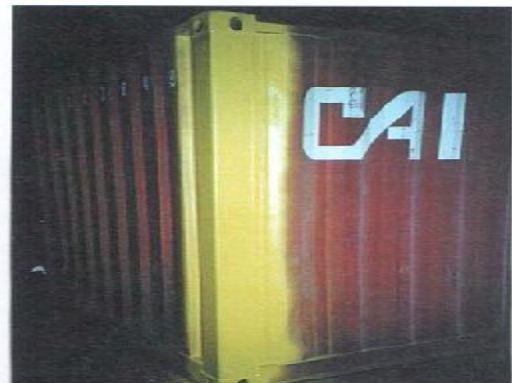
Photo 2.28 / Priming of replacement front corner post

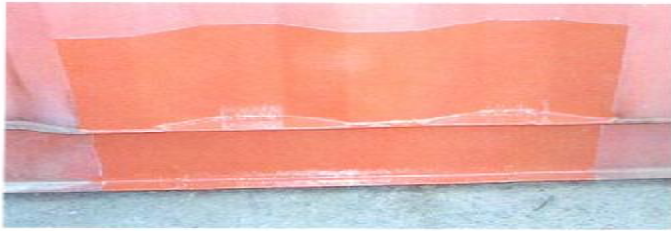
Photo 2.33 / Top coating of bottom rail section completed.

Photo 2.33 / Top coating of bottom rail section completed.

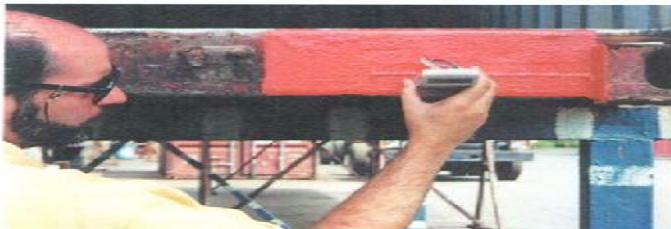
Photo 2.34 / Use of an electronic dry-film paint thickness gauge

Photo 2.34 / Use of an electronic dry-film paint thickness gauge

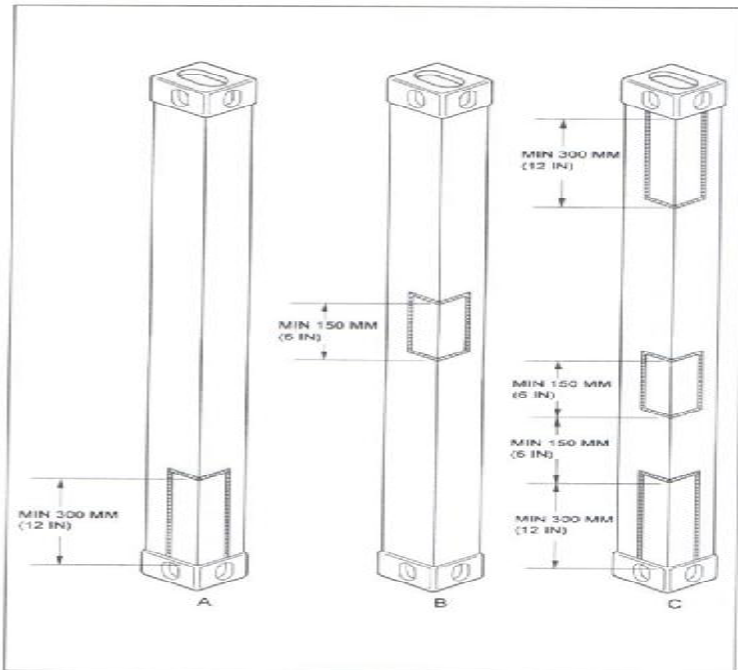
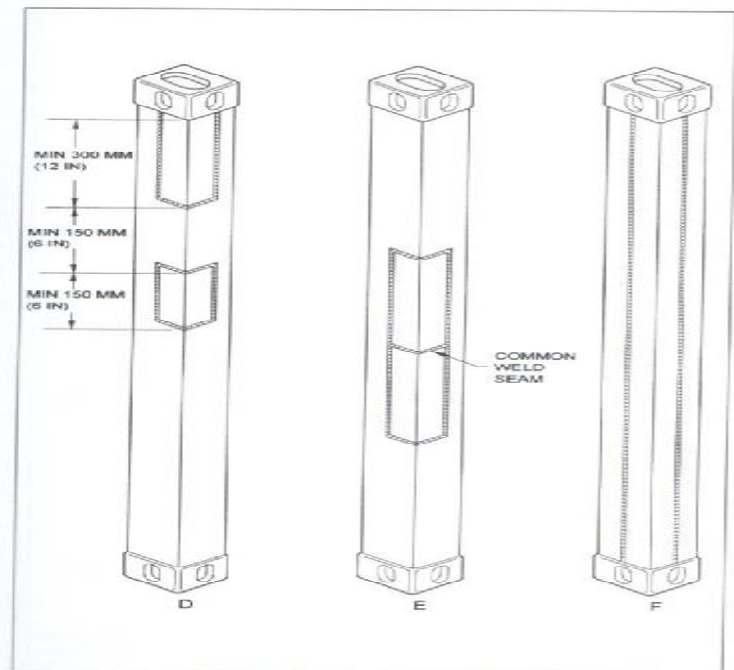
Fig. 4.2/Typical acceptable corner post inserts

Fig. 4.2/Typical acceptable corner post inserts (continued)

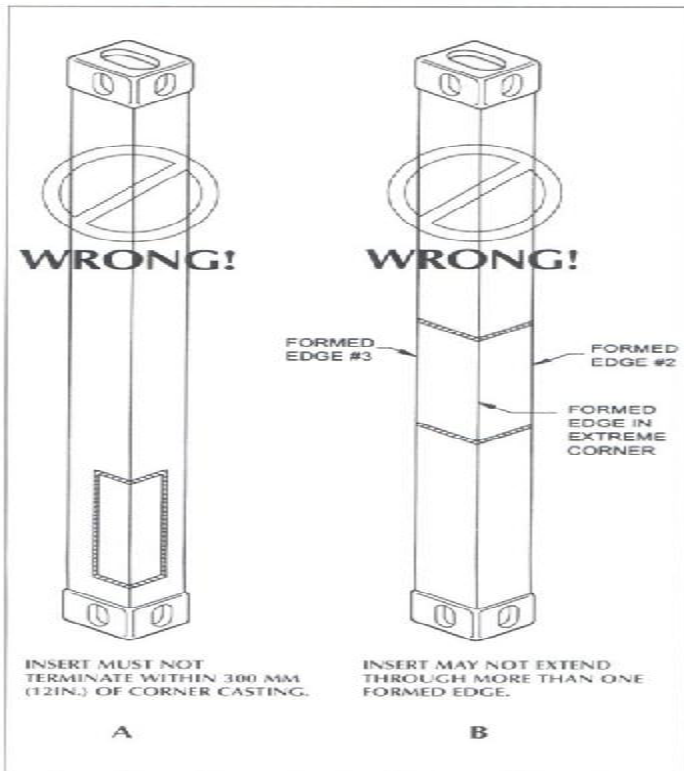
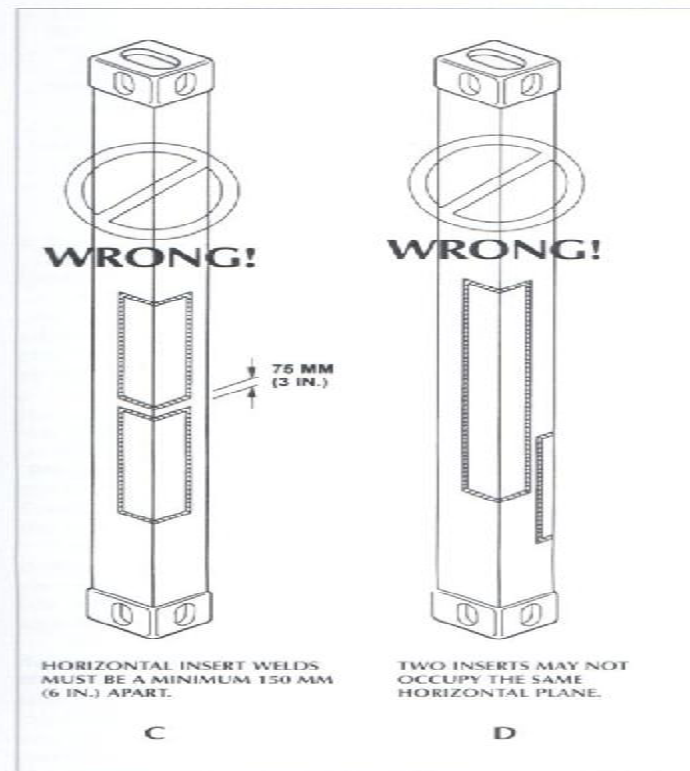
Fig. 4.3/UNACCEPTABLE corner post inserts

Fig. 4.3/UNACCEPTABLE corner post inserts (continued)

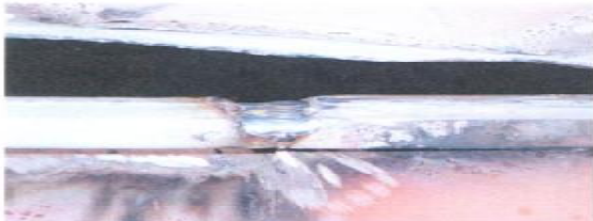
Photo 5.4 / Welding of flat-bar top side rail section to original rail (second pass)

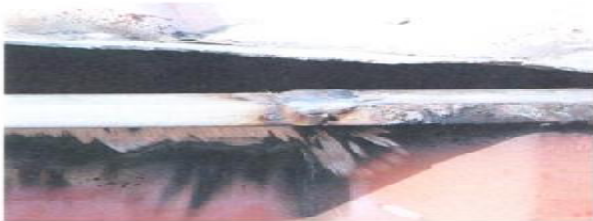
Photo 5.5 / Welding of flat-bar top side rail section to original rail (third pass)

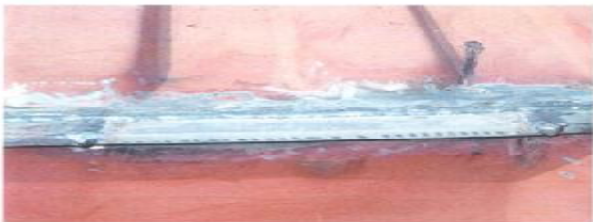
Photo 5.6 / Completed welding of flat-bar top side rail section. A portion of the welds between the section and the original rail has been ground down to permit proper reattachment of the roof sheet.

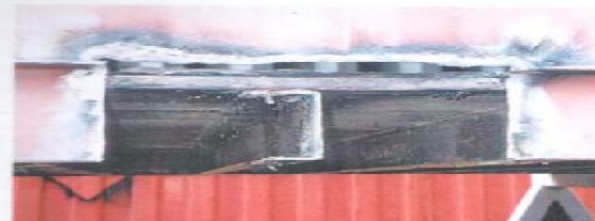
Photo 5.7 / Removal of damaged portion of bottom side rail. Note cutting of welds to side panel beyond the removed area of rail.

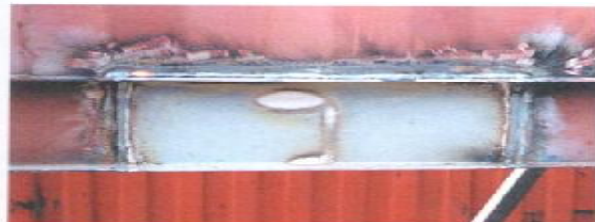
Photo 5.8 / Welding of bottom rail section to original rail, panel and crossmember

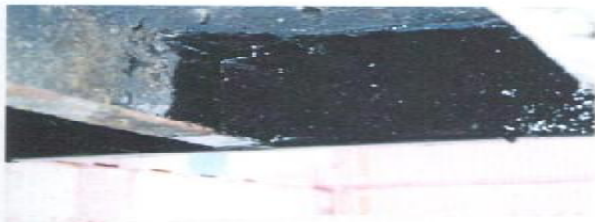
Photo 5.9 / Undercoating bottom rail section (primer was applied beforehand)

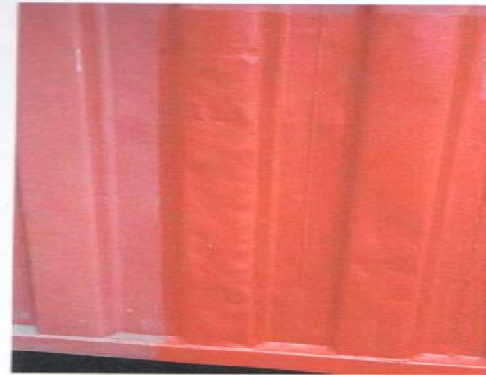
Photo 6.1 / Example of good panel straightening, with well-formed corrugation profile (although with a few hammer marks)

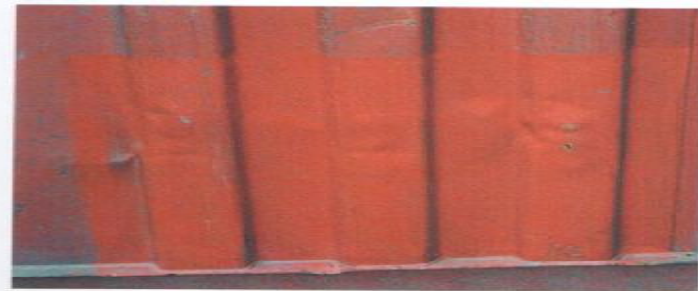
Photo 6.2 / Example of fair panel straightening, with fair corrugation profile and more serious hammer marks

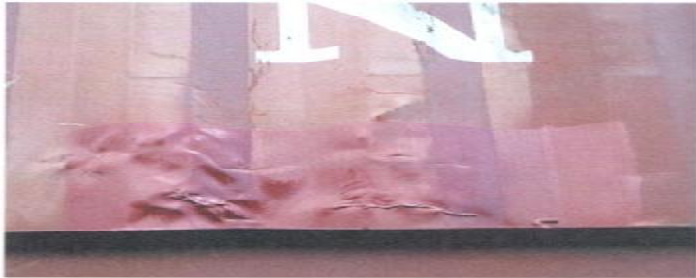
Photo 6.3 / Example of poor panel straightening, with numerous deep hammer marks and poor corrugation profile

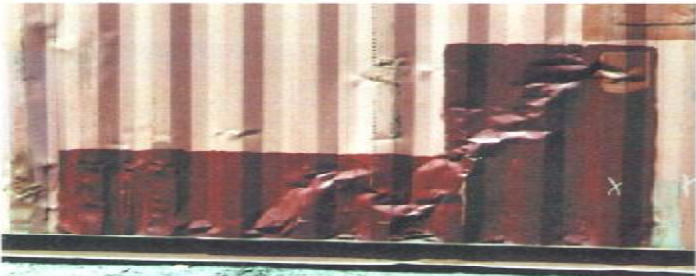
Photo 6.4 / Example of poor panel straightening. The damaged area has been painted, but no attempt has been made to straighten the dents.

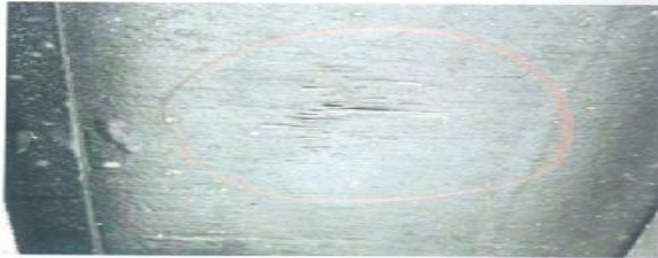
Photo 4.3 Finger crack (in circled area) on underside of floor, directly below the impact shown in Photo 4.2. Since this is accompanied by a sign of impact, this is considered *damage*.

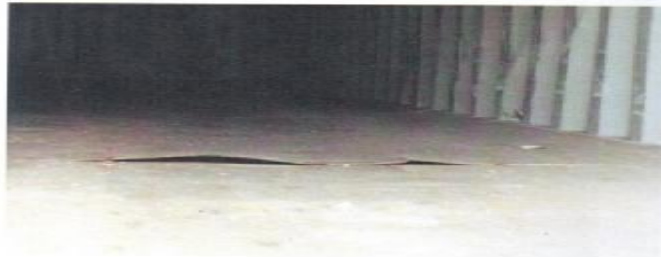
Photo 4.4 Delaminated plywood board, *without* indication of either impact or overloading and *without* breakage of an outer veneer. This is a *wear* item.

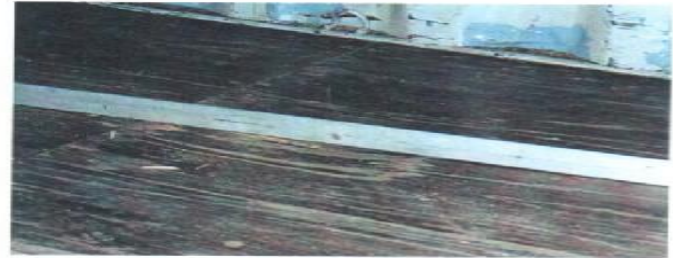
Photo 4.5 Wavy floor is a sign of delamination. Check for accompanying conditions (*e.g.* sagging crossmembers under the wavy area) to determine whether this is a damage or wear condition.

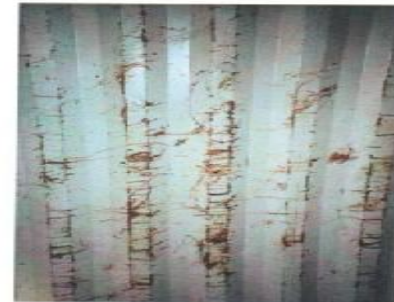
Photo 4.6 Numerous scratches on recessed as well as standing corrugations. This is a *damage* condition.

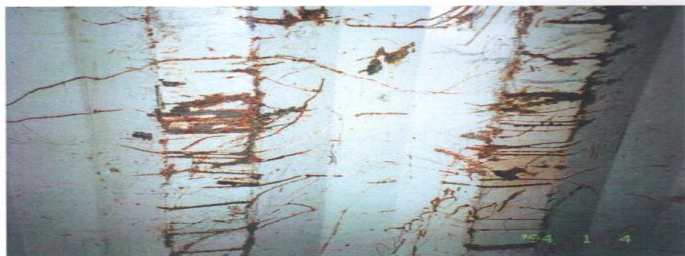
Photo 4.7 Individual deep scratches on corrugations. This is a *damage* condition.

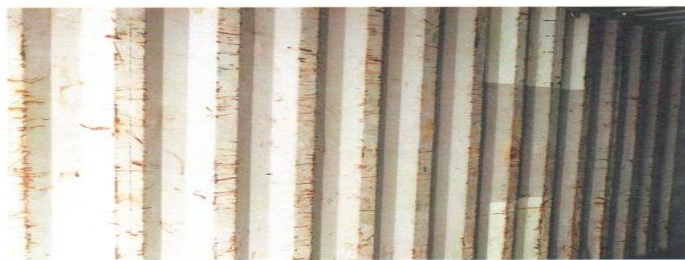
Photo 4.8 Normal-use scratches on standing corrugations. Note the relative absence of scratches on recessed corrugations. This is a *wear* condition.

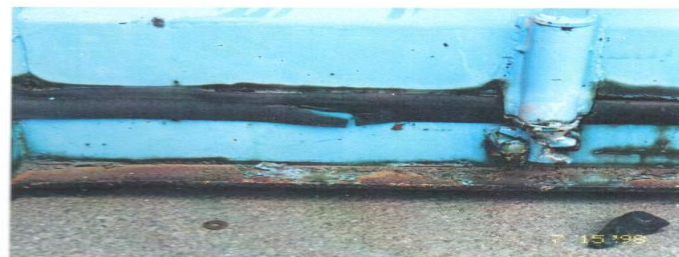
Photo 4.9 Bottom horizontal gasket with cuts. This gasket does *not* require repair as long as it is still watertight.

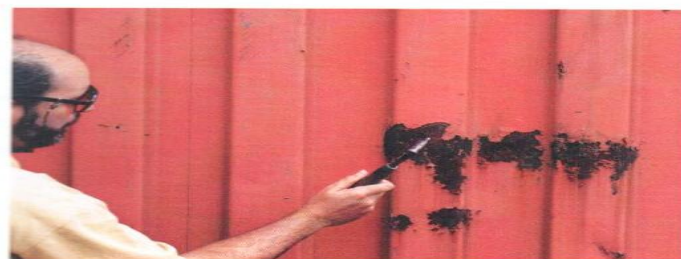
Photo 4.10 Use of the inspector's hammer; if the corroded area shown permanently deforms or becomes holed when struck by a short series of light blows from the hammer, repair is necessary. This is a *wear* condition. If there is no deformation or holing, no repair is required.

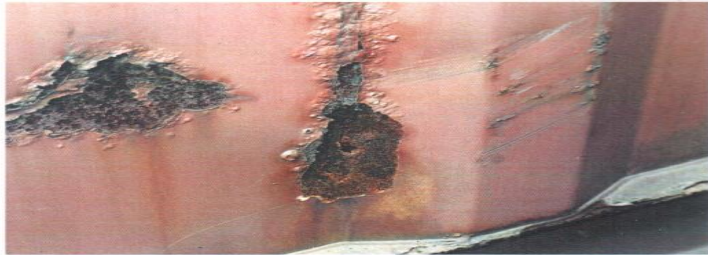
Photo 4.11 Corroded area holed by the inspector's hammer test. This is a *wear* condition which must be repaired.

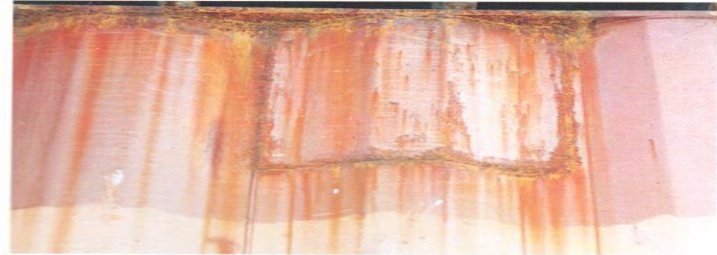
Photo 4.13 Surface corrosion due to improper surface preparation and painting of top side rail and panel patch (exterior). The degree of corrosion does not require repair by itself, although the condition still may be repair-worthy depending on the owner's policy on correcting improper repairs of this type.

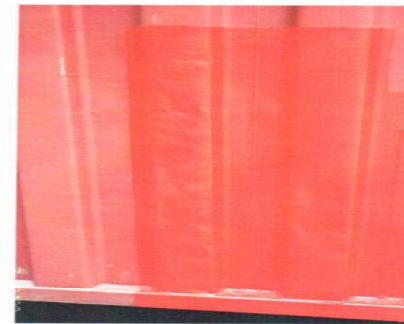
Photo 4.14 Good straightening of a front panel. No rework required.

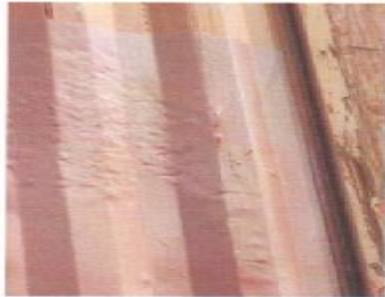
Photo 4.15 Acceptable panel straightening. Despite many hammer marks, the corrugation profile was reasonably restored; rework is not required.

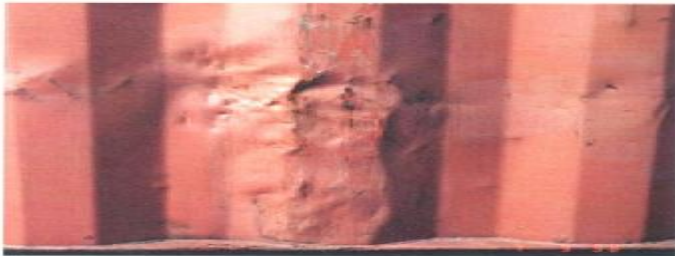
Photo 4.16 Borderline-quality panel straightening. Numerous hammer marks and only a feeble attempt made to restore corrugation profile. The need to rework is dependent on owner's policies.

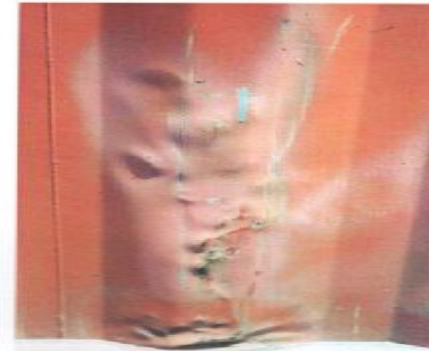
Photo 4.17 Poor-quality panel straightening. Only a feeble attempt made to restore corrugation profile, using a large-headed hammer without a corrugation dolly. There is significant stretching of metal. No attempt at surface preparation has been made. Rework subject to owner's policies.

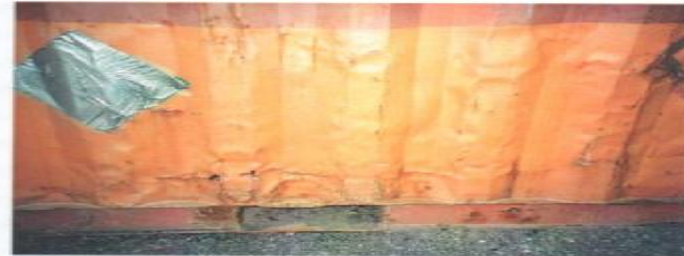
Photo 4.18 Poor-quality panel straightening. No attempt made to restore corrugation profile. Poor-quality painting and paint mismatch. Rework required (subject to owner's policies).

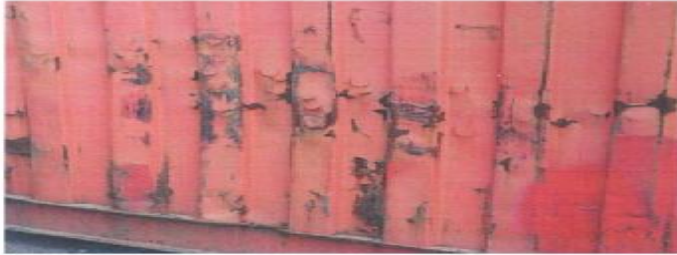
Photo 4.19 Poor-quality panel straightening. Numerous hammer marks and no surface preparation or painting. Rework required (subject to owner's policies).

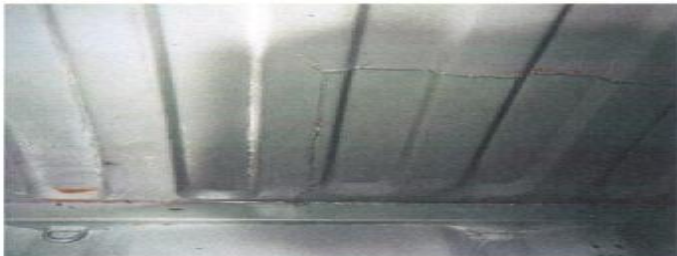
Photo 4.20 Insert to a roof panel with a different corrugation profile at the end. No rework required.

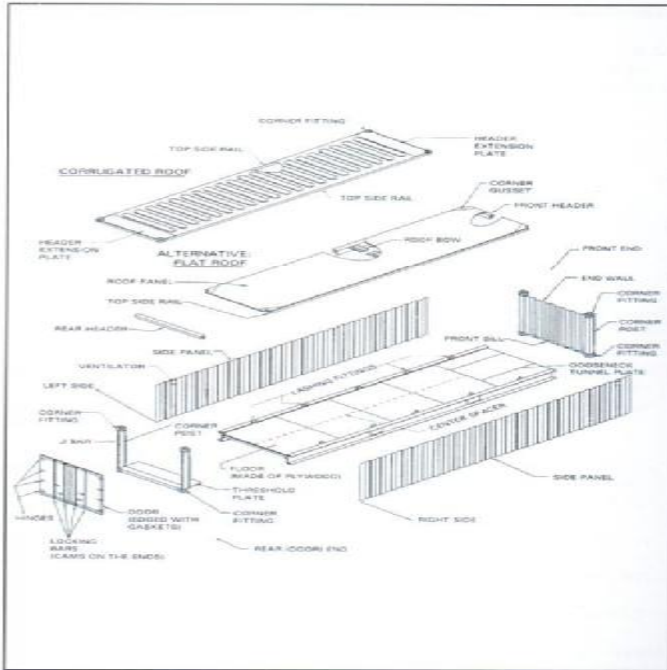
Fig. 1/General arrangement of 40-foot container components

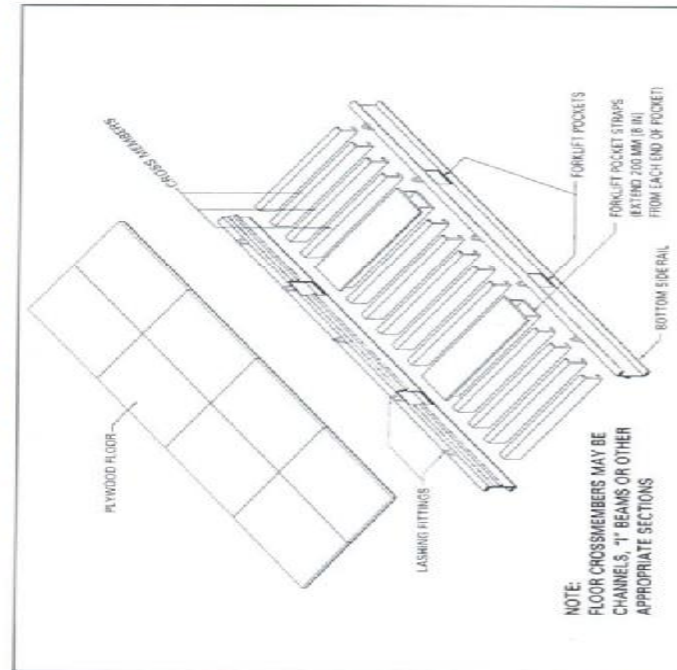
Fig. 2/Exploded diagram-base and flooring of 20-foot container

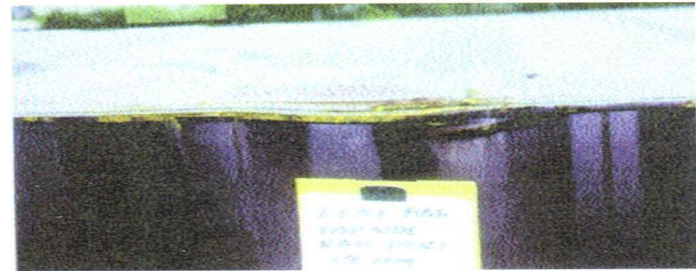
REPAIR NOT REQUIRED

Flat bar top side rail dented less than 25 mm (1 in).

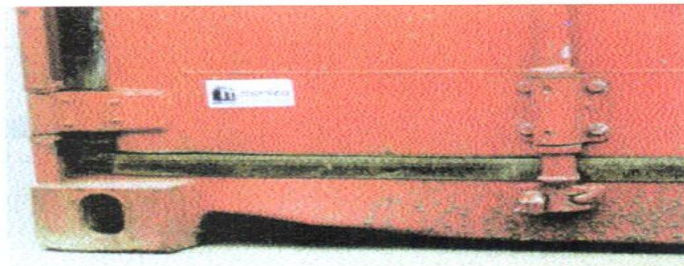
REPAIR REQUIRED

Bottom side rail torn and weld broken.

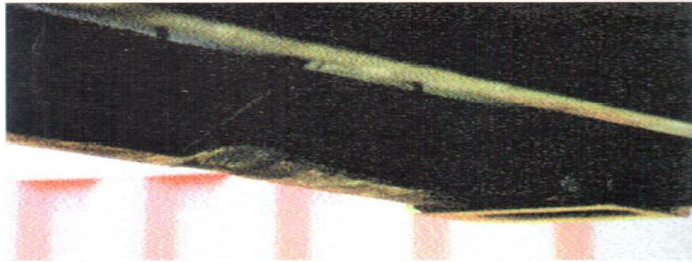
REPAIR NOT REQUIRED
Flange of bottom end rail not torn, cracked or cut, and web undamaged.

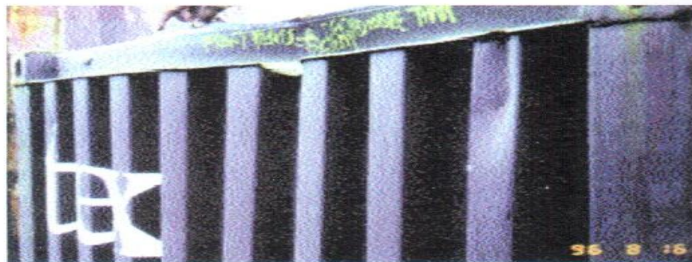
REPAIR REQUIRED
Front header deformed more than 25 mm (1 in).

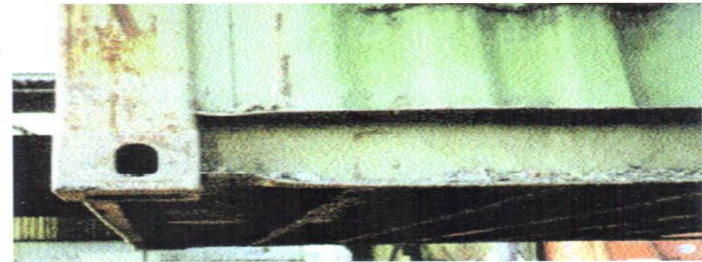
NEED TO REPAIR UNDETERMINED
Since dent to bottom side rail is within 250 mm (10 in) of corner fitting, the weld to the fitting must be carefully examined and repaired if there is any evidence of break, cut, tear, crack or other damage.

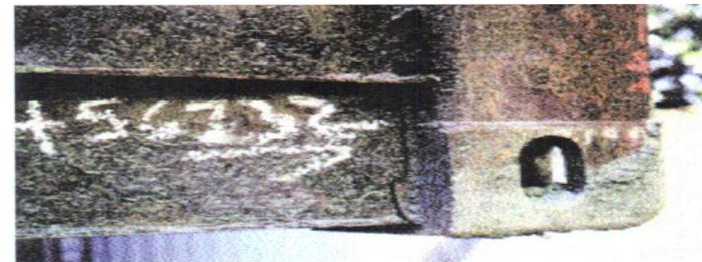
REPAIR REQUIRED
Bottom rail cracked.

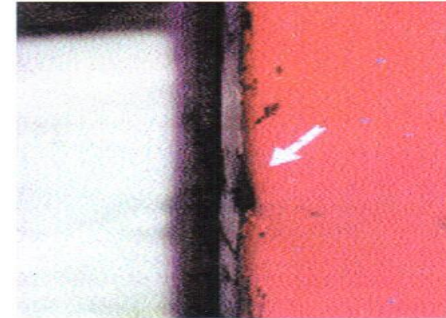
REPAIR REQUIRED
Corner post holed.

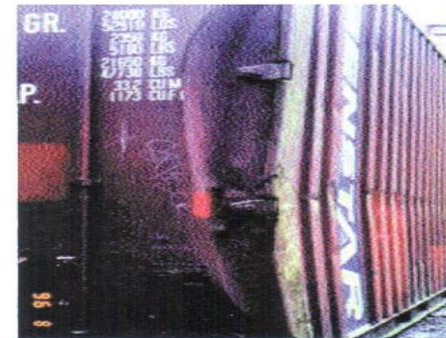
NEED TO REPAIR UNDETERMINED

Measure depth of bow in post and also dent in adjacent door panel, and check door operation. NOTE: If either post or door panel is repairworthy, both components must be repaired.

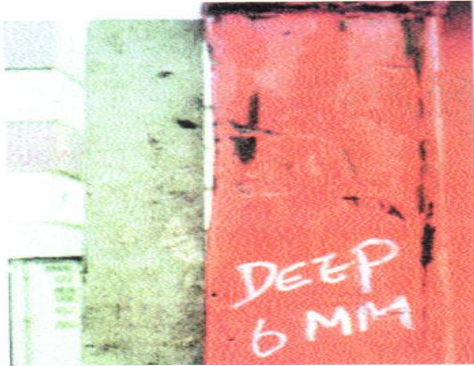
REPAIR NOT REQUIRED
Corner post not dented in excess of 25 mm (1 in).

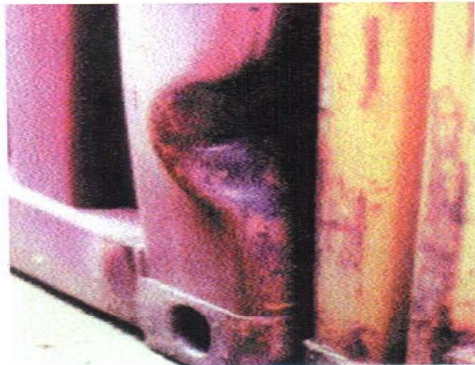
REPAIR REQUIRED
Corner post dented more than 25 mm (1 in).

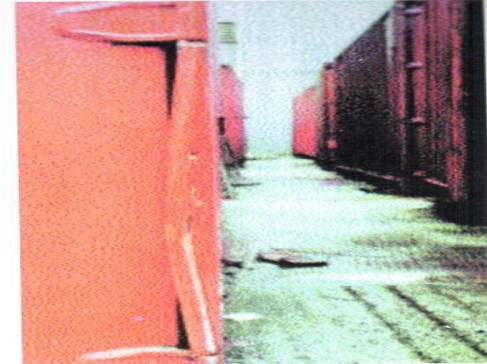
REPAIR REQUIRED
J-bar bend impairs door operation.

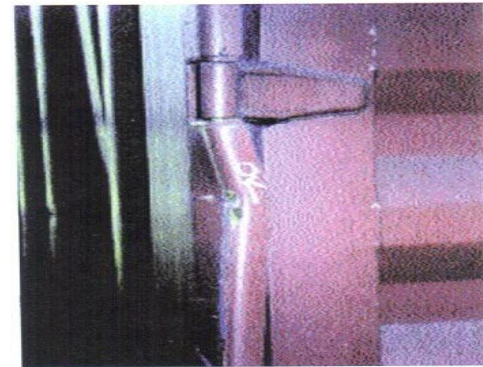
REPAIR NOT REQUIRED
Bent J-bar does not impair door operation or securement.

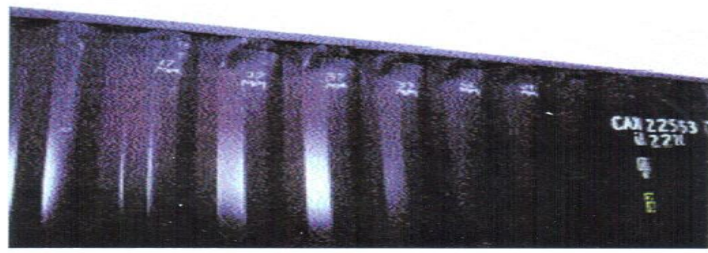
REPAIR REQUIRED
Outboard corrugation of side panel dented more than 35 mm (1-3/8 in). Repair is only required to 37 mm (1-7/16 in) dents; the other dents do not have to be repaired, as the compression rule no longer applies.

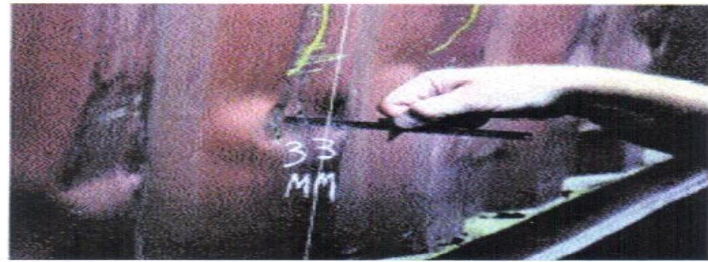
REPAIR NOT REQUIRED
Outboard corrugation of side panel dented less than 35 mm (1-3/8 in).

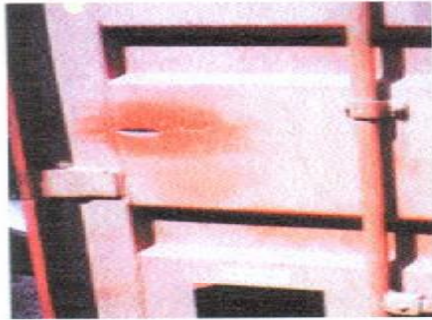
REPAIR REQUIRED
Hole in door panel

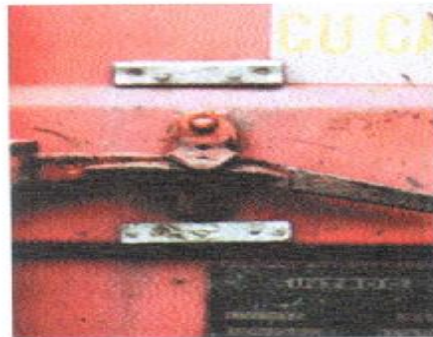
REPAIR NOT REQUIRED
Bent door handle does not impair door operation or securement.

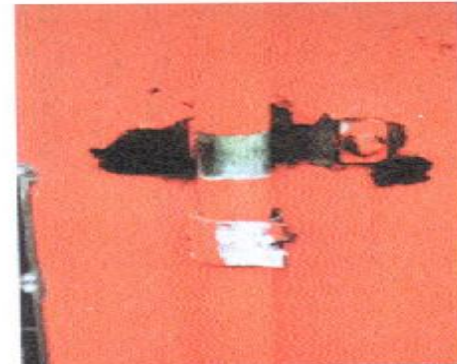
REPAIR REQUIRED
Broken locking bar guide.

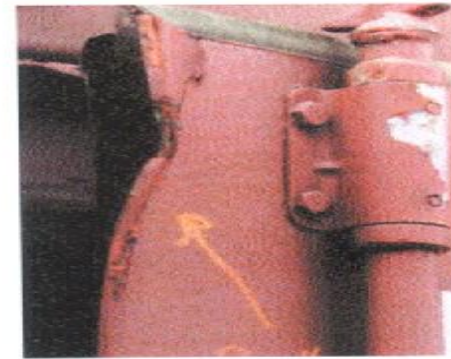
NEED TO REPAIR UNDETERMINED
Door panel dented less than 35 mm (1-3/8 in), which does not require repair. However, if door is **not both** water-tight **and** light-tight, repair **would** be required.

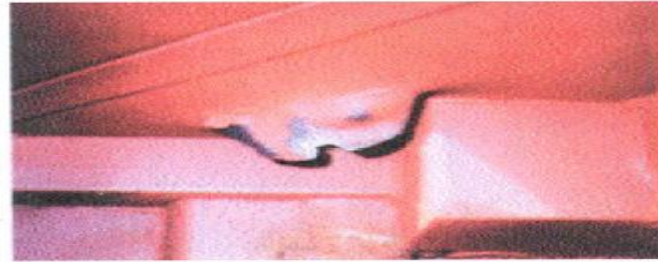
REPAIR REQUIRED
Corner protection plate holed.

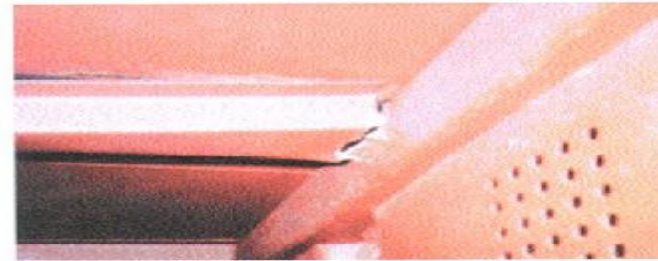
REPAIR REQUIRED
Roof bow weld to top side rail is broken.

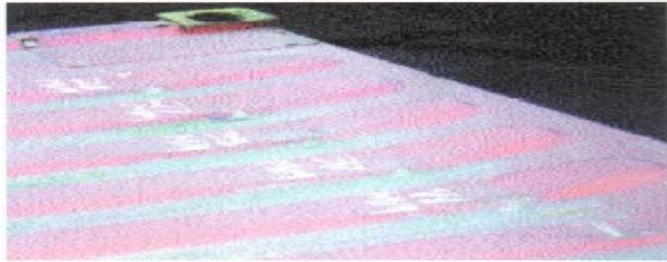
REPAIR REQUIRED

Dent in corrugation more than 35 mm (1-3/8 in) deep. Only the 41 mm (1-5/8 in) and 37 mm (1-7/16 in) dents need to be repaired.

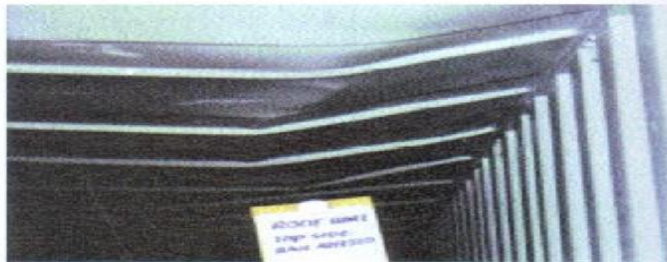
NEED TO REPAIR UNDETERMINED

Measure depth of roof panel dent and tip side rail deformation to see if either exceeds damage limits. Check deformation against ISO tolerances.

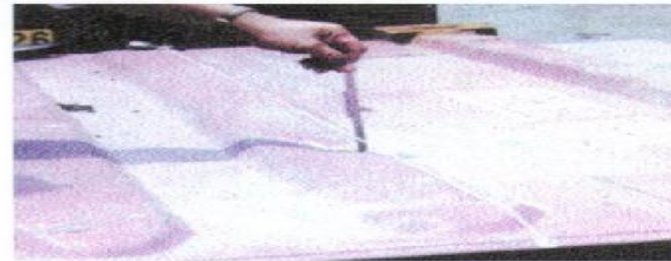
NEED TO REPAIR UNDETERMINED

Repair if dent is more than 35 mm (1-3/8 in).

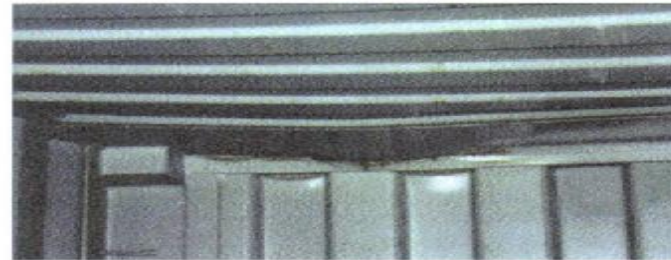
REPAIR NOT REQUIRED

Damage to header extension plate does not reduce internal dimensions by more than 50 mm (2 in).

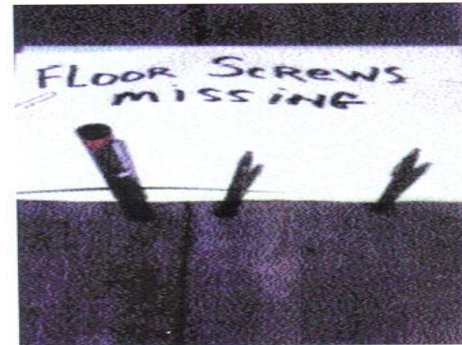
REPAIR REQUIRED
Fasteners missing.

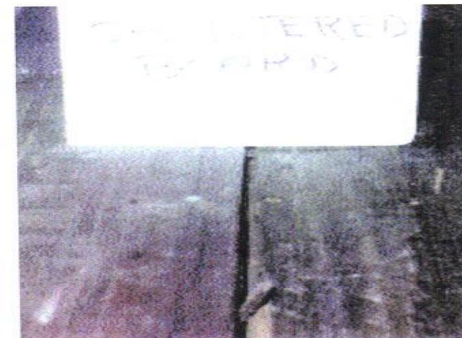
REPAIR REQUIRED
Splintered.

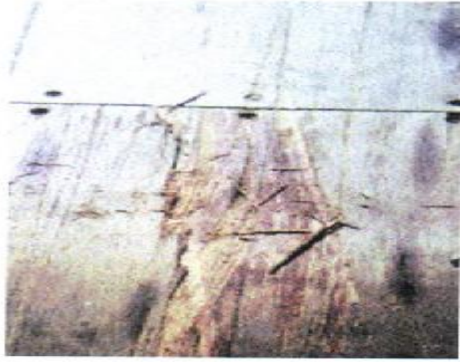
REPAIR NOT REQUIRED
Gouge in top veneer of plywood less than 150 mm (6 in) wide and 5 mm (3/16 in) deep.

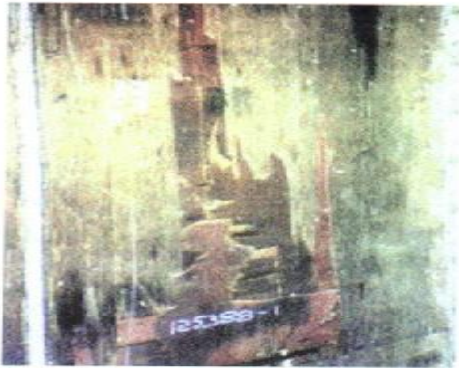
REPAIR REQUIRED
Delamination.

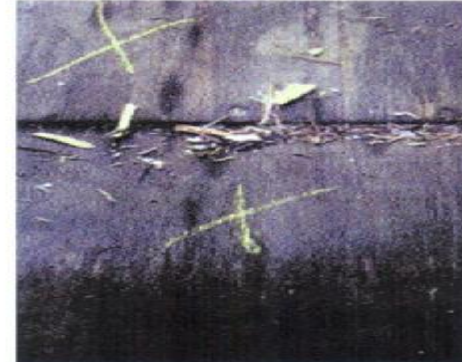
REPAIR REQUIRED
Heights of adjacent plywood panels differ by more than 5 mm (3/16 in).

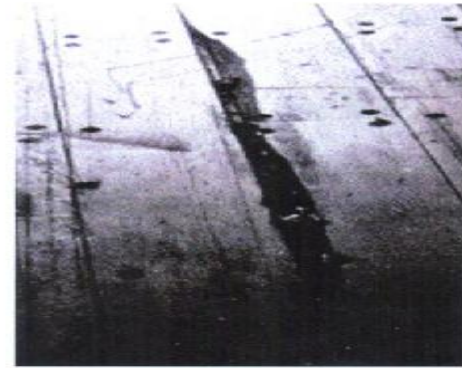
REPAIR REQUIRED
Gouge in floor boards more than 15 mm (9/16 in) deep.

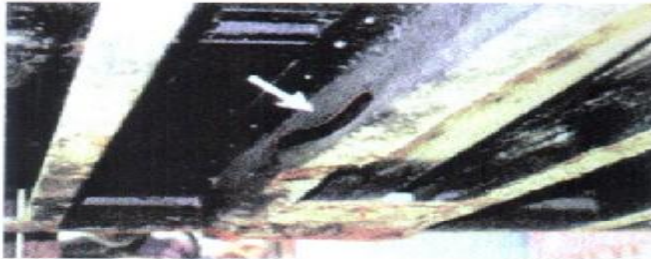
REPAIR REQUIRED
Forklift pocket side holed.

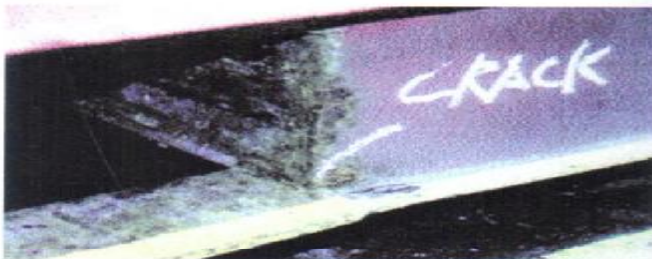
REPAIR REQUIRED
Forklift pocket strap weld cracked.

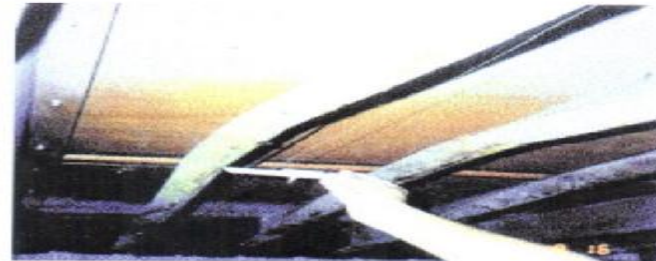
REPAIR REQUIRED
Crossmember web deformed more than 50 mm (2 in).

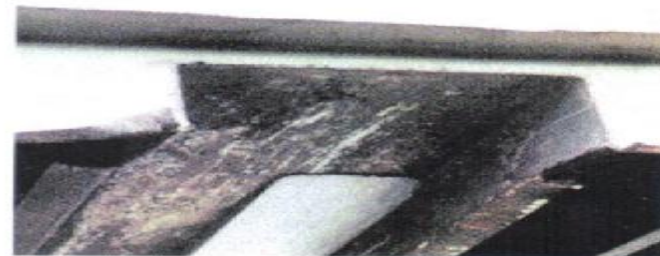
REPAIR REQUIRED
Forklift pocket strap missing.

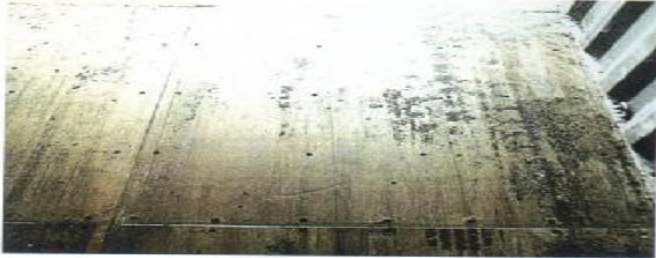
CONDITION PHOTO 6.5/Dust and dirt that is *unacceptable* to shippers or lessees for shipment of dry-van cargo.

Action Required If This Condition is Present	Repair
Recommended Cleaning Method	Hot high-pressure wash

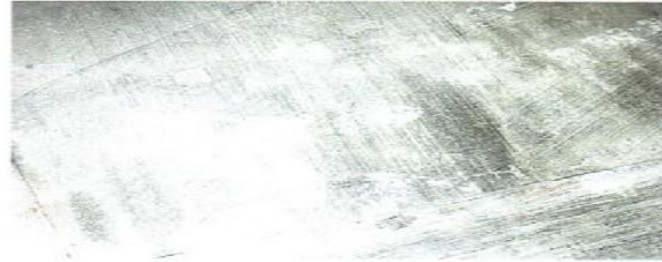
CONDITION PHOTO 6.6/Transferable or non-transferable *dried* mud foot prints that would normally remain after a sweep out, and that would *not* damage dry-van general cargo.

Action Required If This Condition is Present	No repair
Recommended Cleaning Method	Not applicable

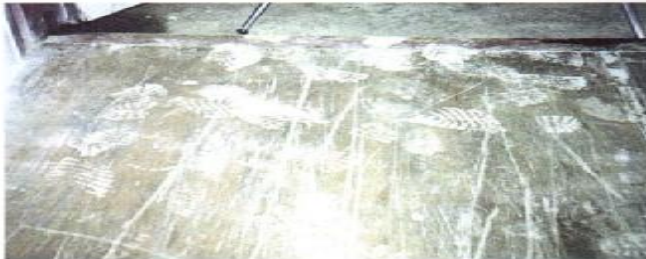
CONDITION PHOTO 6.7/Raised mud foot prints (i.e., footprints having a discernable thickness) in excess of what normally would remain after a sweep out.

Action Required If This Condition Is Present	Repair
Recommended Cleaning Method	Sweep

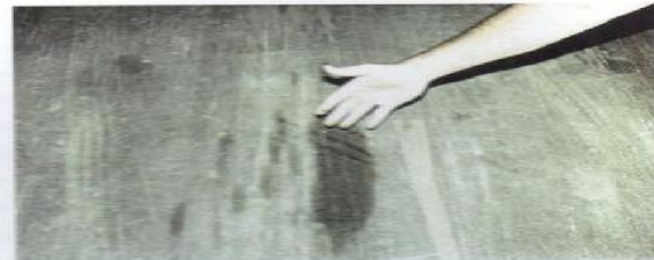
CONDITION PHOTO 6.8/Dry dust covering dried floor stains as would normally remain after a sweep out.

Action Required If This Condition Is Present	No repair
Recommended Cleaning Method	Not applicable

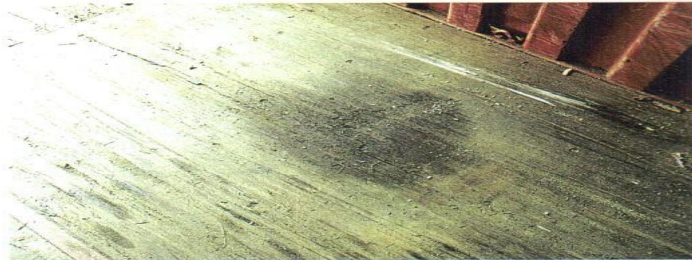
CONDITION PHOTO 6.9/Dry dust covering floor stains in an amount greater than would normally remain after a sweep out, and that would *not* be acceptable to the shipper or lessee.

Action Required If This Condition Is Present	Repair
Recommended Cleaning Method	Sweep

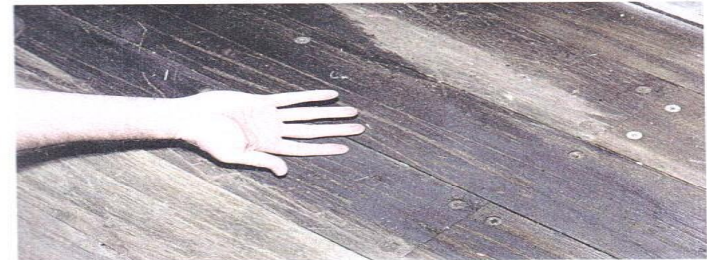
CONDITION PHOTO 6.10/Transferable damp floor stain that would *not* damage dry-van general cargo.

Action Required If This Condition Is Present	No repair
Recommended Cleaning Method	Not applicable
