Box repair and surveys

General repair procedures

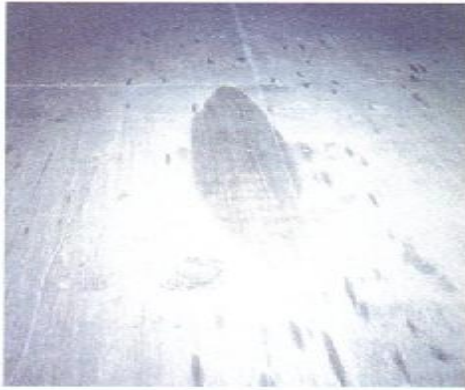
CONDITION PHOTO 6.11/Transferable or non-transferable dried floor stains that will *not* damage dry-van general cargo.

Action Required If This Condition Is Present	No repair
Recommended Cleaning Method	Not applicable

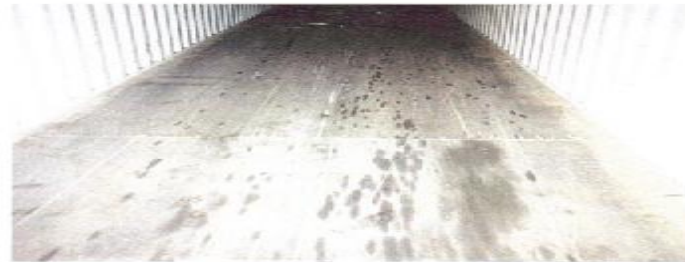
CONDITION PHOTO 6.12/Transferable or non-transferable dried floor stains that will *not* damage dry-van cargo.

Action Required If This Condition Is Present	No repair
Recommended Cleaning Method	Not applicable

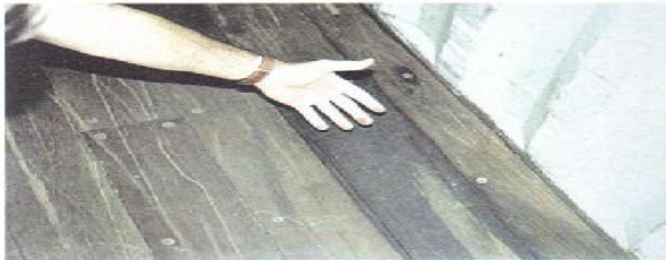
CONDITION PHOTO 6.13/Damp oil stain that is transferable and that would damage dry-van general cargo.

Action Required If This Condition Is Present	Repair
Recommended Cleaning Method	Hot high-pressure wash

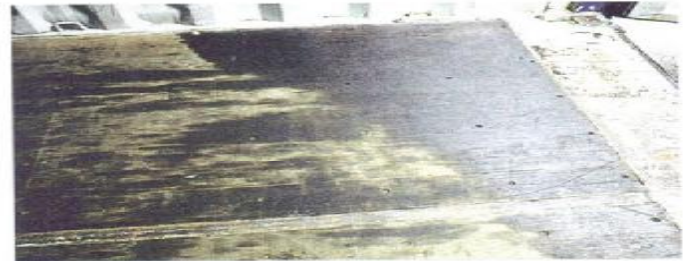
CONDITION PHOTO 6.14/Damp and transferable oil stains that would damage dry-van general cargo.

Action Required If This Condition Is Present	Repair
Recommended Cleaning Method	Hot high-pressure wash

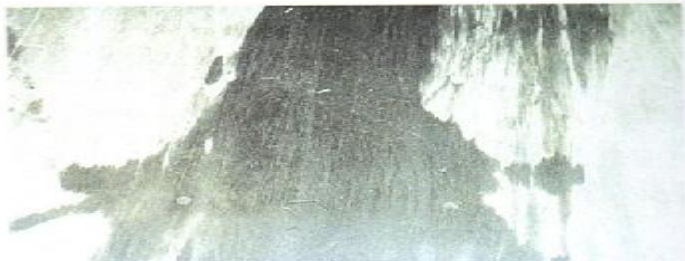
CONDITION PHOTO 6.15/Transferable, damp, liquid stain that would damage dry-van general cargo.

Action Required If This Condition Is Present	Repair
Recommended Cleaning Method	Cold high-pressure wash

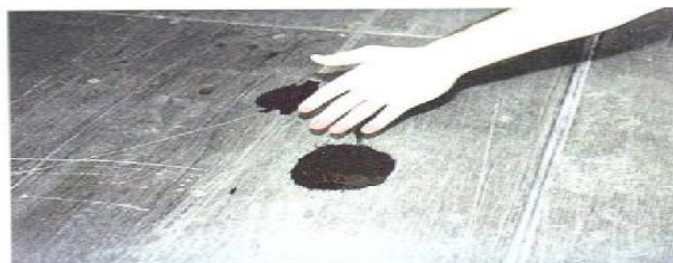
CONDITION PHOTO 6.16/Pooled oil on floor surface that would damage cargo and impede the safe loading and operation of the container.

Action Required If This Condition Is Present	Repair
Recommended Cleaning Method	Spot clean

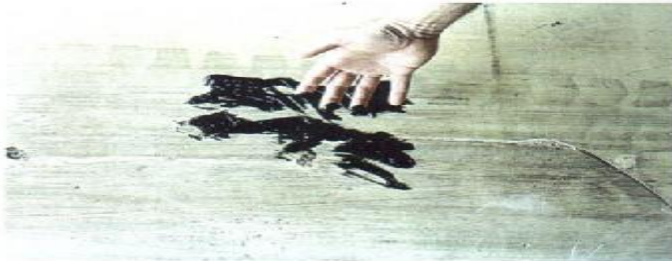
CONDITION PHOTO 6.17/Tar stain that would damage cargo and impede the safe loading and operation of the container.

Action Required If This Condition Is Present	Repair
Recommended Cleaning Method	Scrape/ spot clean

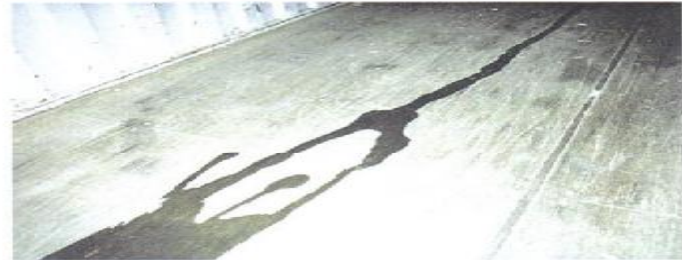
CONDITION PHOTO 6.18/Wet, standing and pooled liquid that would damage cargo.

Action Required If This Condition Is Present	Repair
Recommended Cleaning Method	Hot high-pressure wash

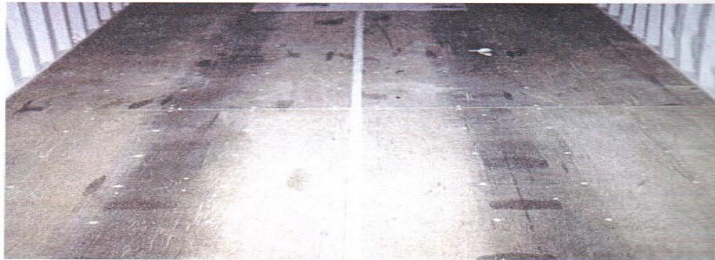
CONDITION PHOTO 6.19/Forklift tire marks on floor that would *not* damage dry-van general cargo.

Action Required If This Condition Is Present	No repair
Recommended Cleaning Method	Not applicable

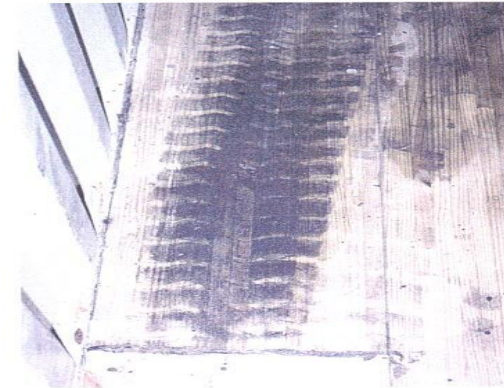
CONDITION PHOTO 6.20/Forklift tire marks on floor that would *not* damage dry-van general cargo.

Action Required If This Condition Is Present	No repair
Recommended Cleaning Method	Not applicable

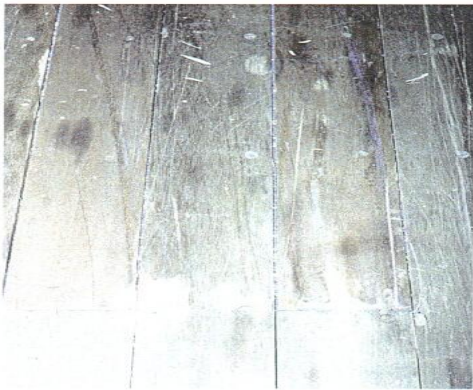
CONDITION PHOTO 6.21/Polyethylene beads between floorboard grooves and on floor surface that would normally remain after a sweep out and would *not* damage dry-van general cargo.

Action Required If This Condition Is Present	No repair
Recommended Cleaning Method	Not applicable

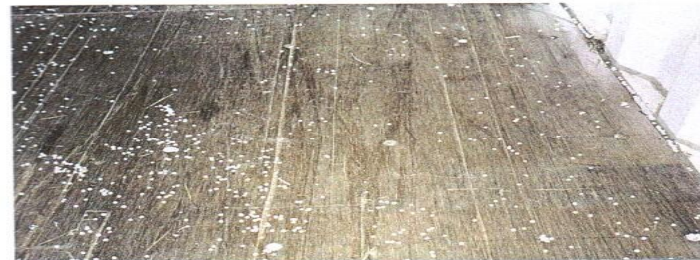
CONDITION PHOTO 6.22/Polyethylene beads remaining on floor surface and stuck to caulking that would impede the safe loading and operation of a container.

Action Required If This Condition Is Present	Repair
Recommended Cleaning Method	Sweep

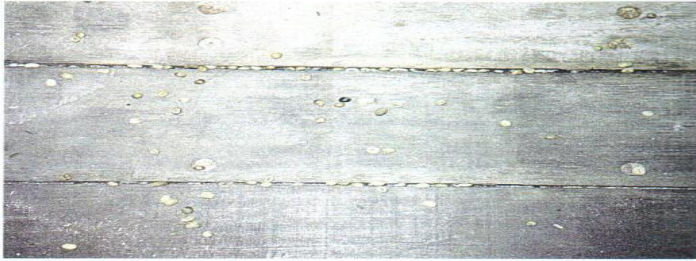
CONDITION PHOTO 6.23/Organic residue (e.g., coffee beans) remaining inside container. All organic materials inside the container *must* be removed.

Action Required If This Condition Is Present	Repair
Recommended Cleaning Method	Scrape/sweep

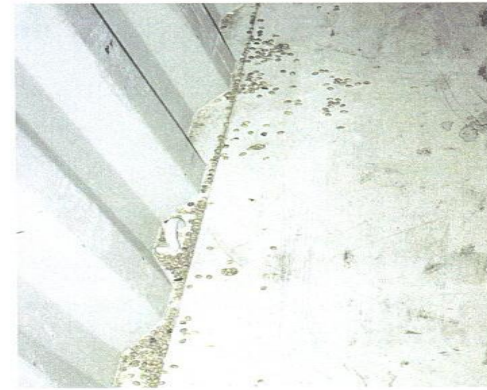
CONDITION PHOTO 6.24/Organic residue on floor. All organic materials inside the container *must* be removed.

Action Required If This Condition Is Present	Repair
Recommended Cleaning Method	Sweep

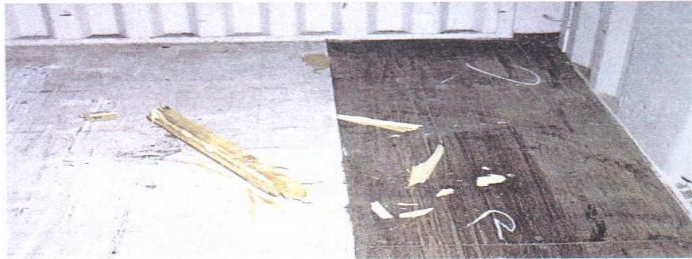
CONDITION PHOTO 6.25/Debris and dunnage that would damage dry-van general cargo and impede the safe loading and operation of the container.

Action Required If This Condition Is Present	Repair
Recommended Cleaning Method	Remove

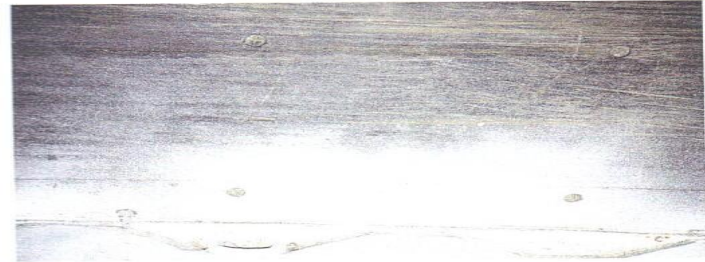
CONDITION PHOTO 6.26/Paint spills that will *not* transfer to cargo.

Action Required If This Condition Is Present	No repair
Recommended Cleaning Method	Not applicable

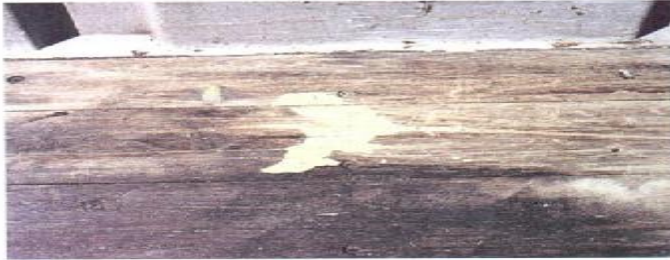
CONDITION PHOTO 6.27/Paint spills that will *not* transfer to cargo.

Action Required If This Condition Is Present	No repair
Recommended Cleaning Method	Not applicable

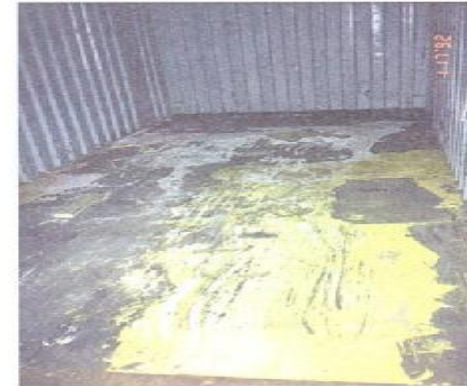
CONDITION PHOTO 6.28/Major paint spillage that would *not* be acceptable to a shipper or lessee.

Action Required If This Condition Is Present	Repair
Recommended Cleaning Method	Power sanding

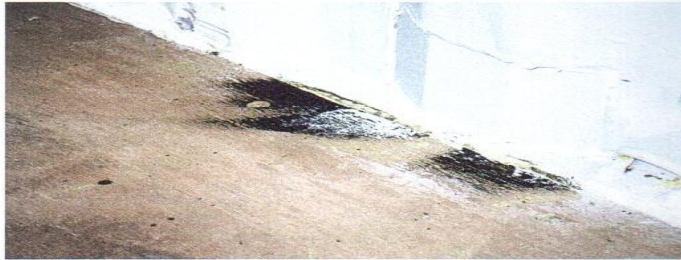
CONDITION PHOTO 6.29/Transferable burn marks on floor that will *not* damage dry-van general cargo.

Action Required If This Condition Is Present	No repair
Recommended Cleaning Method	Not applicable

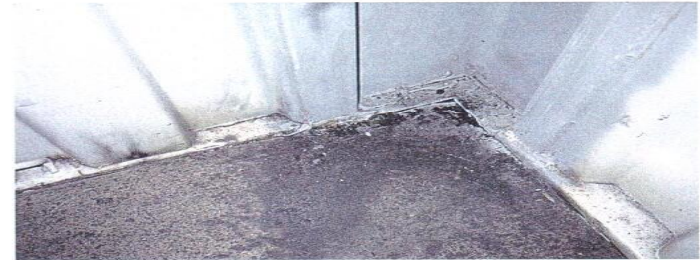
CONDITION PHOTO 6.30/Transferable burn marks on floor that could damage dry-van general cargo and are *not* acceptable to shippers or lessees for dry-vans.

Action Required If This Condition Is Present	Repair
Recommended Cleaning Method	Power sanding

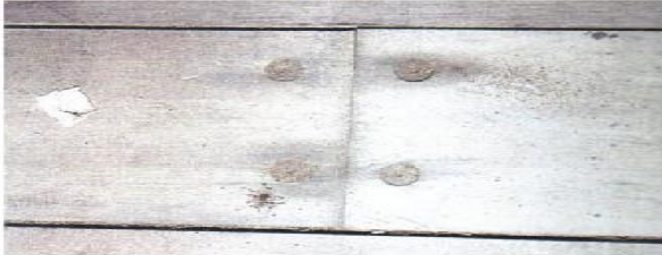
CONDITION PHOTO 6.31/Floor screw corrosion that will not damage dry-van general cargo.

Action Required If This Condition Is Present	No repair
Recommended Cleaning Method	Not applicable

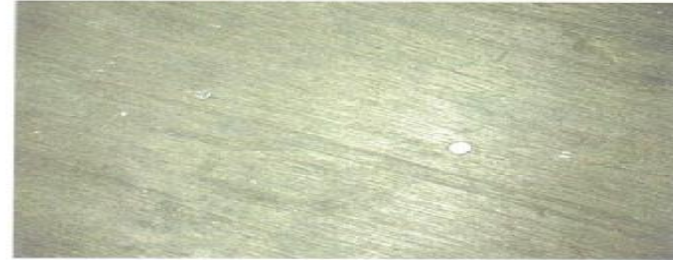
CONDITION PHOTO 6.32/Nail heads that are flush to surface and will *not* damage dry-van general cargo and will *not* impede the safe loading and operation of the container.

Action Required If This Condition Is Present	No repair
Recommended Cleaning Method	Not applicable

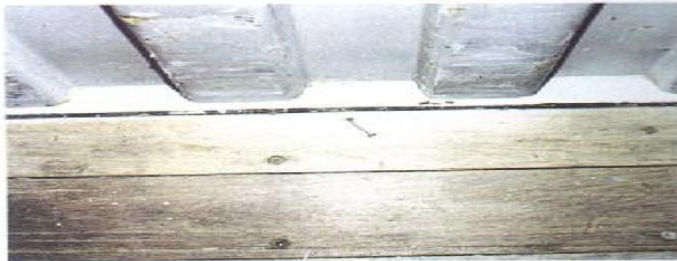
CONDITION PHOTO 6.33/Nails protruding above floor which could damage dry-van general cargo and could impede the safe loading and operation of the container.

Action Required If This Condition Is Present	Repair
Recommended Cleaning Method	Remove

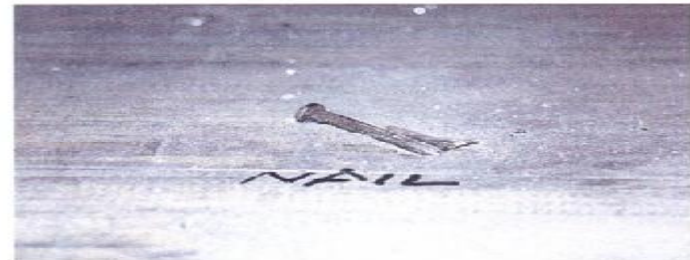
CONDITION PHOTO 6.34/Nails protruding above floor surface which will damage dry-van general cargo and impede the safe loading and operation of the container.

Action Required If This Condition Is Present	Repair
Recommended Cleaning Method	Remove

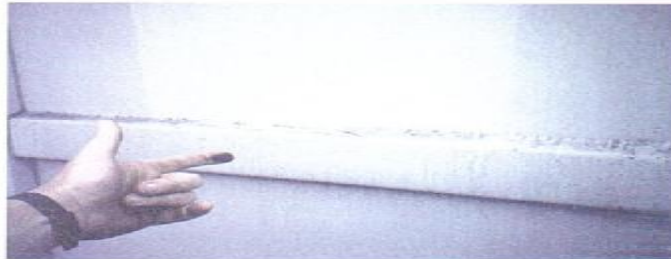
CONDITION PHOTO 6.35/Dust and dirt on walls that will damage dry-van general cargo.

Action Required If This Condition Is Present	Repair
Recommended Cleaning Method	Washing

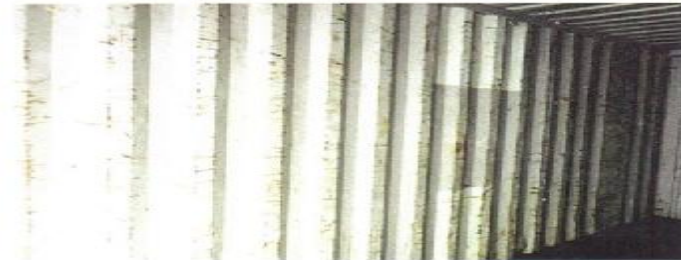
CONDITION PHOTO 6.36/Accumulated scratches due to normal use of container.

Action Required If This Condition Is Present	No repair
Recommended Cleaning Method	Not applicable

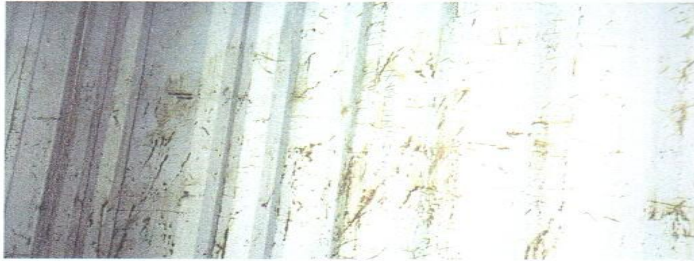
CONDITION PHOTO 6.39/Scratches due to cargo loading that would *not* be acceptable to a shipper or lessee for shipment of dry-van general cargo, but *would* be acceptable for open-top cargo.

Action Required If This Condition Is Present	Repair
Recommended Cleaning Method	Grind/ paint

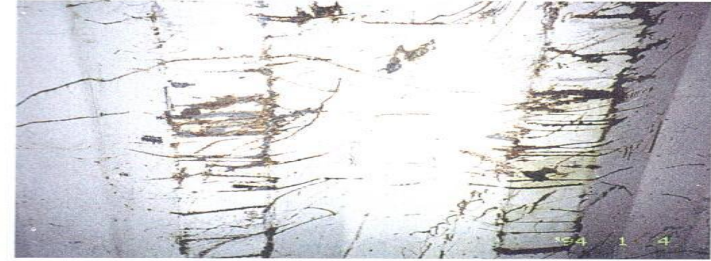
CONDITION PHOTO 6.40/Scratches due to cargo loading that would *not* be acceptable to a shipper or lessee for shipment of dry-van general cargo.

Action Required If This Condition Is Present	Repair
Recommended Cleaning Method	Grind/ paint

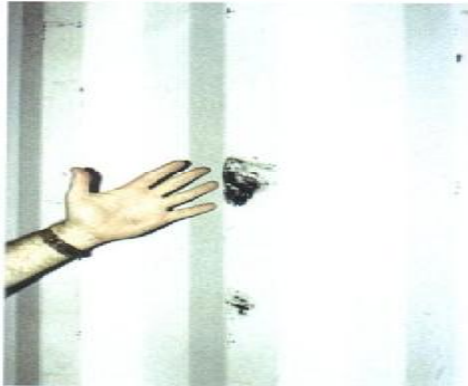
CONDITION PHOTO 6.43/Non-transferable stains that would *not* damage dry-van general cargo.

Action Required If This Condition Is Present	No repair
Recommended Cleaning Method	Not applicable

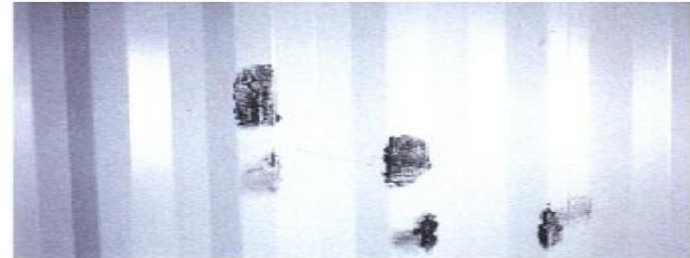
CONDITION PHOTO 6.44/Non-transferable stains that would *not* damage dry-van general cargo and that would be acceptable for shipment of general cargo.

Action Required If This Condition Is Present	No repair
Recommended Cleaning Method	Not applicable

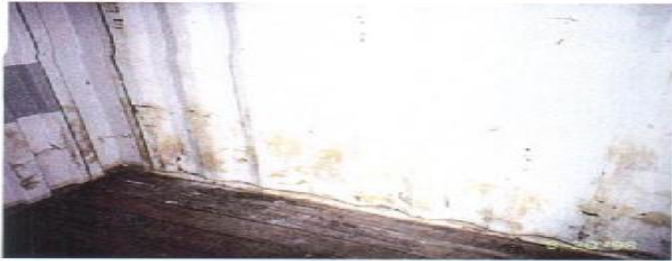
CONDITION PHOTO 6.47/Non-transferable wall stains that would be acceptable for shipment of dry-van general cargo.

Action Required If This Condition Is Present	No repair
Recommended Cleaning Method	Not applicable

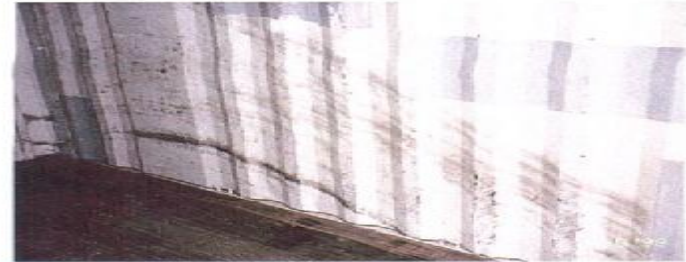
CONDITION PHOTO 6.48/Non-transferable wall stains that would be acceptable for shipment of dry-van general cargo.

Action Required If This Condition Is Present	No repair
Recommended Cleaning Method	Not applicable

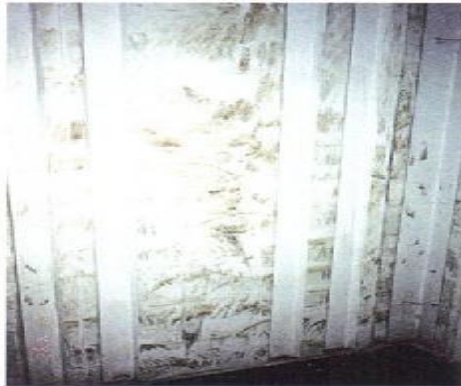
CONDITION PHOTO 6.49/Non-transferable wall stains that would be acceptable for shipment of dry-van general cargo.

Action Required If This Condition Is Present	No repair
Recommended Cleaning Method	Not applicable

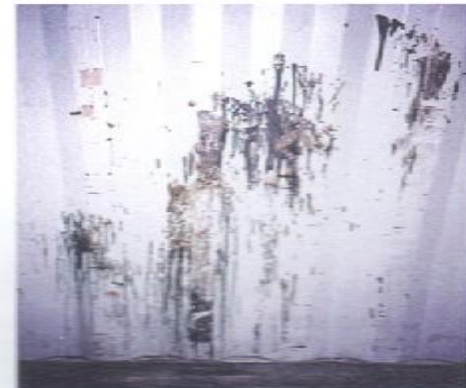
CONDITION PHOTO 6.50/Non-transferable wall stains that would not be acceptable to a shipper or lessee for shipment of dry-van general cargo.

Action Required If This Condition Is Present	Repair
Recommended Cleaning Method	Power grind/ paint

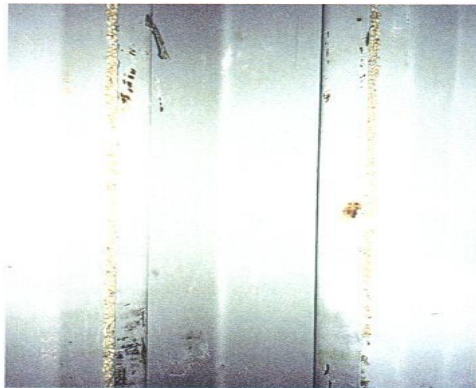
CONDITION PHOTO 6.53/Organic residues stuck to caulking. All organic materials in the container *must* be removed.

Action Required If This Condition Is Present	Repair
Recommended Cleaning Method	Scrape

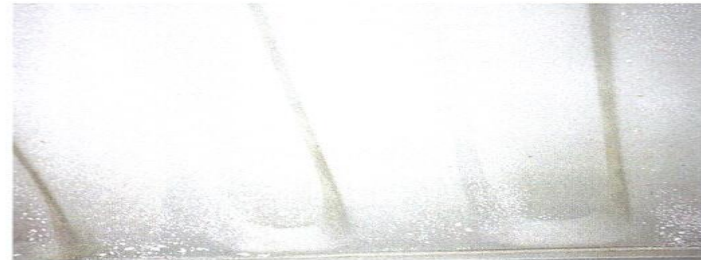
CONDITION PHOTO 6.54/Mold and/or mildew. All organic materials *must* be removed.

Action Required If This Condition Is Present	Repair
Recommended Cleaning Method	Hot high-pressure wash

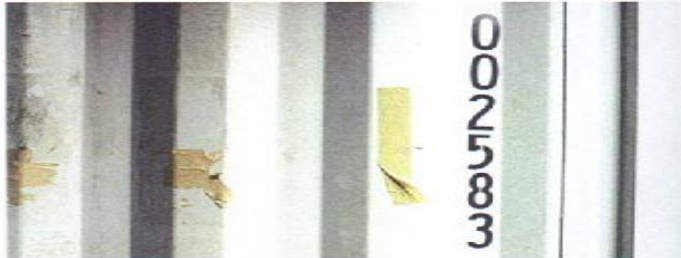
CONDITION PHOTO 6.55/Tape remaining on walls that would *not* be acceptable to a shipper or lessee for shipment of cargo.

Action Required If This Condition Is Present	Repair
Recommended Cleaning Method	Scrape/ spot clean

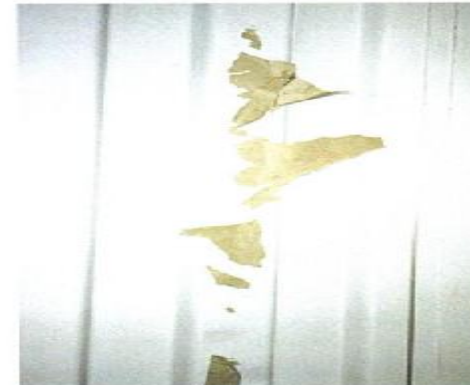
CONDITION PHOTO 6.56/Lining paper remaining on walls that would *not* be acceptable to a shipper or lessee for shipment of cargo.

Action Required If This Condition Is Present	Repair
Recommended Cleaning Method	Scrape

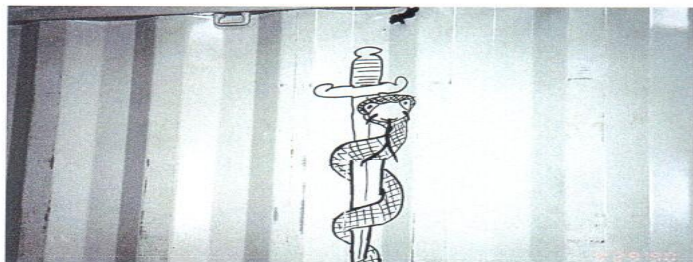
CONDITION PHOTO 6.61/Graffiti, not related to cargo, that would *not* be acceptable for shipment of general dry-van cargo.

Action Required If This Condition Is Present	Repair
Recommended Cleaning Method	Paint over

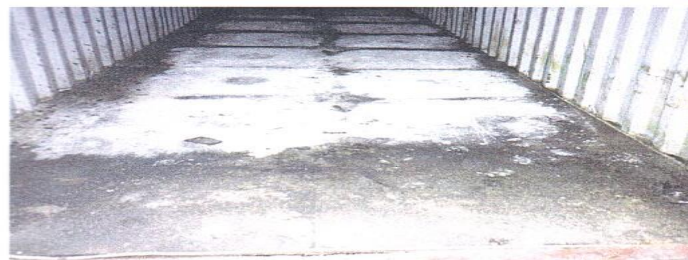
CONDITION PHOTO 6.62/Evidence of possible toxic or hazardous material regardless of quantity or transferability.

Action Required If This Condition Is Present	Repair
Recommended Cleaning Method	*1

Graffiti removed or over painted and hazardous cargo to removed with caution and based on clear information on the product

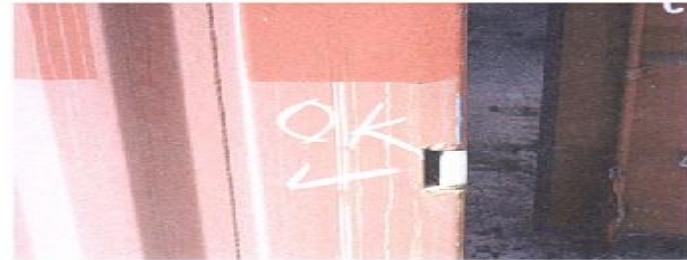
CONDITION PHOTO 6.66/Depot marks that would be acceptable for shipment of dry-van cargo.

Action Required If This Condition Is Present	No repair
Recommended Cleaning Method	Not applicable

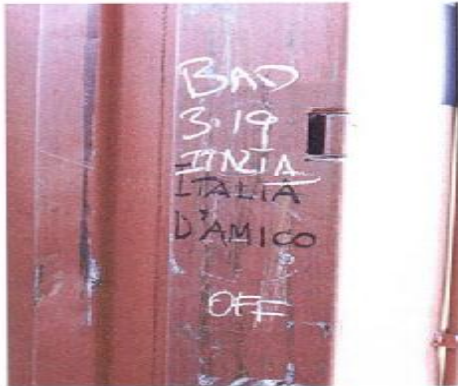
CONDITION PHOTO 6.67/ Customer marks that would not be acceptable for shipment of dry-van cargo.

Action Required If This Condition Is Present	Repair
Recommended Cleaning Method	Spot clean/ paint

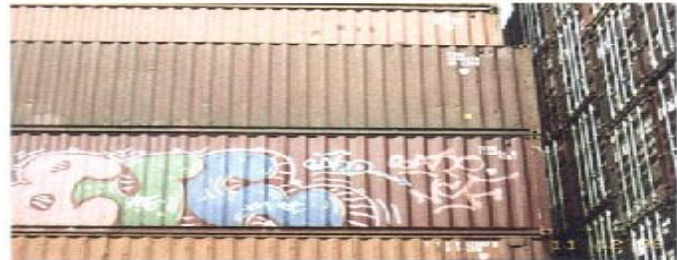
CONDITION PHOTO 6.68/Graffiti that would not be acceptable for shipment of dry-van cargo.

Action Required If This Condition Is Present	Repair
Recommended Cleaning Method	Paint over

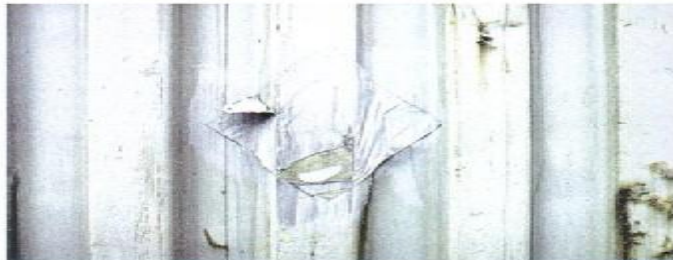
CONDITION PHOTO 6.73/Painted-over labels that would *not* be acceptable for shipment of dry-van cargo.

Action Required If This Condition Is Present	Repair
Recommended Cleaning Method	Scrape

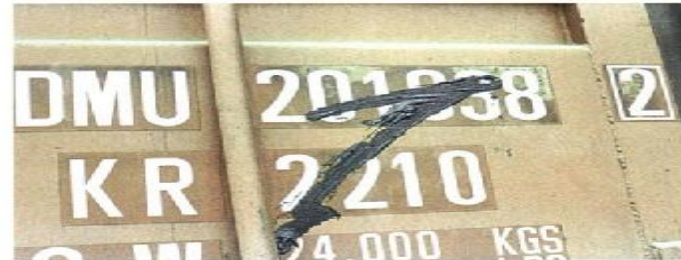
CONDITION PHOTO 6.74/Spillage on exterior that renders ISO markings illegible and would *not* be acceptable for shipment of dry-van cargo.

Action Required If This Condition Is Present	Repair
Recommended Cleaning Method	Spot clean

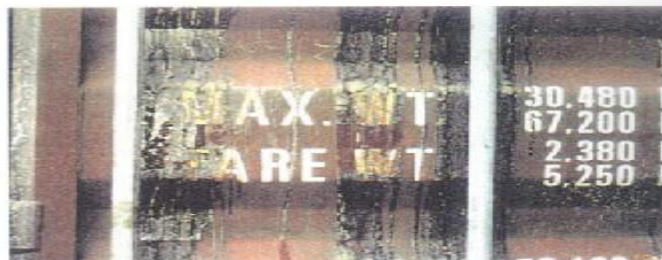
CONDITION PHOTO 6.75/Spillage on exterior that attacks paint and that would *not* be acceptable for shipment of dry-van cargo.

Action Required If This Condition Is Present	Repair
Recommended Cleaning Method	Blast/paint

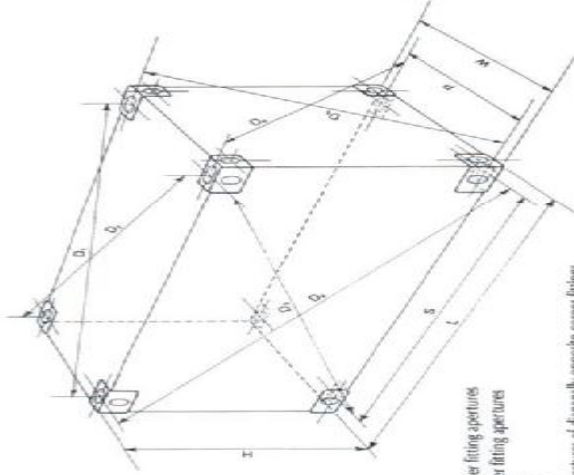
APPENDIX B ISO DIMENSIONS AND TOLERANCES

- S = Length between centers in corner fitting apertures
- P = Width between centers in corner fitting apertures
- L = External length of the container
- W = External width of the container
- D = Distance between centers of diagonally opposite corner fittings
- K₁ = Difference between D₁ and D₂ or D₃ and D₄
- K₂ = Difference between D₅ and D₆
- H = Overall height

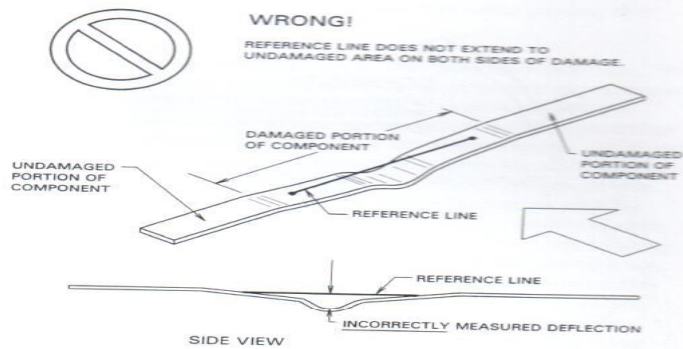
Fig. 2.2/INCORRECT placement of reference line: full damage NOT measured. See Section 2.1.1.

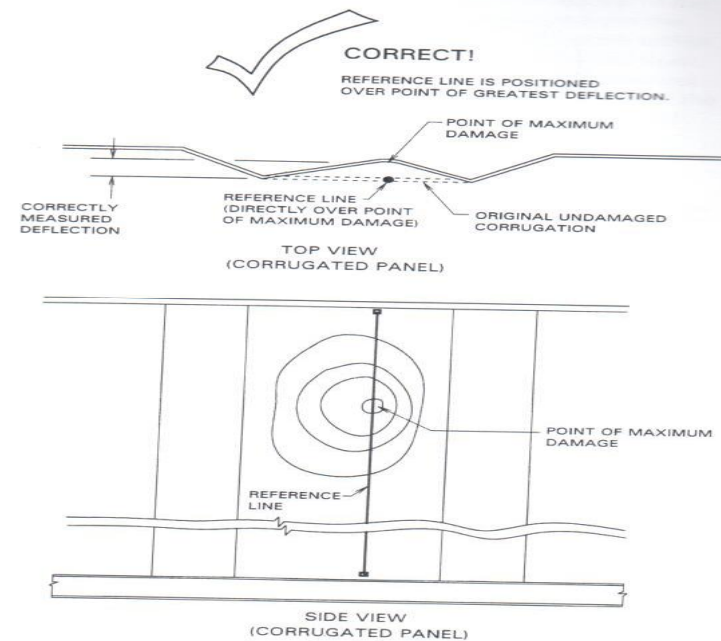
Fig. 2.3/Correct placement of reference line: placed over point of damage. See Section 2.1.1.

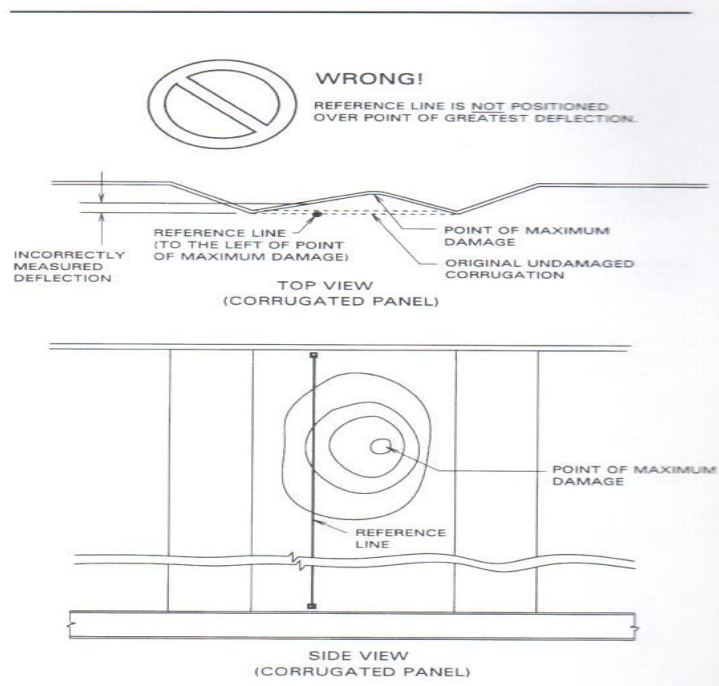
Fig. 2.4/INCORRECT placement of reference line: **NOT** placed over point of maximum damage. See Section 2.1.1.

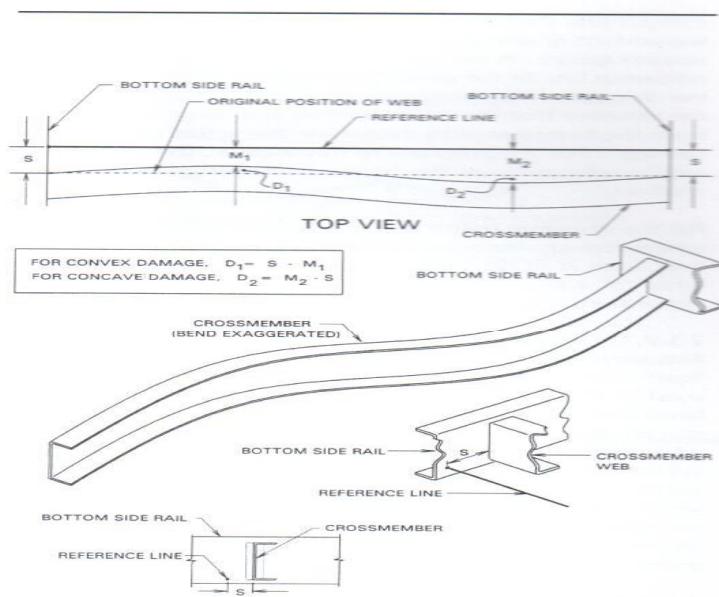
Fig. 2.5/Measuring crossmember web damage when reference line cannot be placed along web. See Section 2.1.2.1.

Figure 2.5 shows the space out/measure back technique used to measure web damage to a crossmember that has been bent in two directions. The string line cannot be placed directly on either side of the web because the adjacent damage interferes with running the line over the entire length of the crossmember. Consequently, the reference line is spaced back from the crossmember web (in actual practice, the reference line is held against the bottom side rail webs a known distance away from the crossmember web), and the damage is determined by measurement and calculation as shown in the figure.

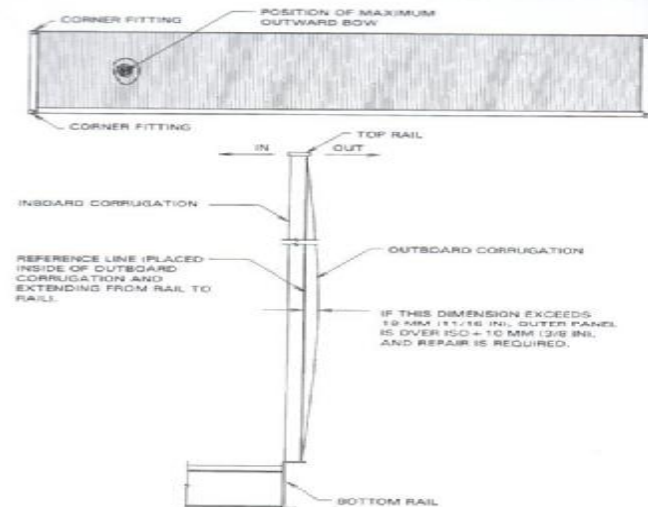
Fig. 2.8/Checking ISO + IICL tolerances when reference line cannot be positioned between two corner fittings over point of maximum damage. See Section 2.2.2.

joining top rail to panel, and extending down to the weld joining bottom rail to panel. The bend, dent or bow depth should be measured in the standard way, from reference line to the point of maximum damage. The assumption is made that the interior surface of an undamaged outboard corrugation is located 8 mm (3/8 in) inwards of the outside vertical face of the corner fittings. The reference dimension in the case illustrated in Figure 2.8 is 18 mm (11/16 in). Therefore, if the measurement exceeds 18 mm (11/16 in), the outward bulge exceeds the ISO + 10 mm (3/8 in) criterion, and must be repaired.

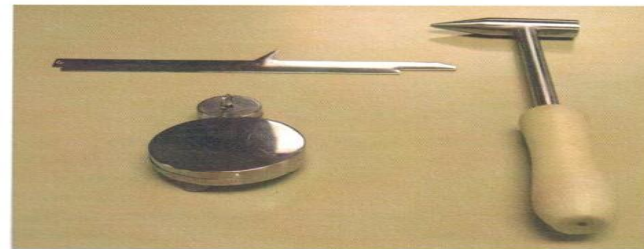
Basic measurement tools for a container inspector. At the left, from top to bottom: a retractable reference line with a magnet attached to end and three magnetic spacers with protruding, notched pins of different heights for holding the reference line. In the center: a taper gauge and a damage scale with 5 mm (3/16 in) and 15 mm (9/16 in) gauges attached. At the far right: a corrosion testing hammer and a standard 3.5 m (12.5 ft) tape measure. The tools are resting on weather-resistant clipboard. See Section 3.1.

The IICL, understanding the need for basic inspection tools, has procured the retractable reference line, ruler, and corrosion testing hammer (see below photo). These tools can now be purchased on line through the IICL web site (www.iicl.org). Additional tools such as those referenced in section 3.1 and 3.2 should be purchased at your own discretion.

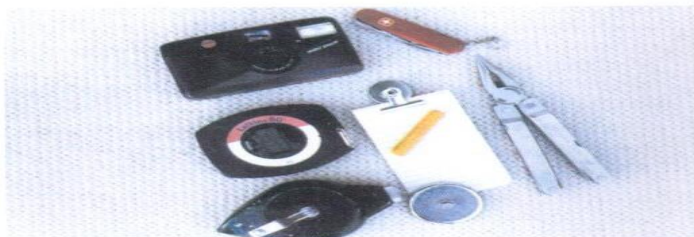
Recommended additional tools for container inspection. Clockwise, starting at top right with red knife: a Swiss Army knife; a multi-purpose folding tool (Leatherermer's tool); a 15.3 m (50 ft) retractable string line with magnet attached to end; a 15.3 m (50 ft) retractable measuring tape; and a small autofocus camera. In the center: chalk and a magnetic clip and note paper. See Section 3.2.

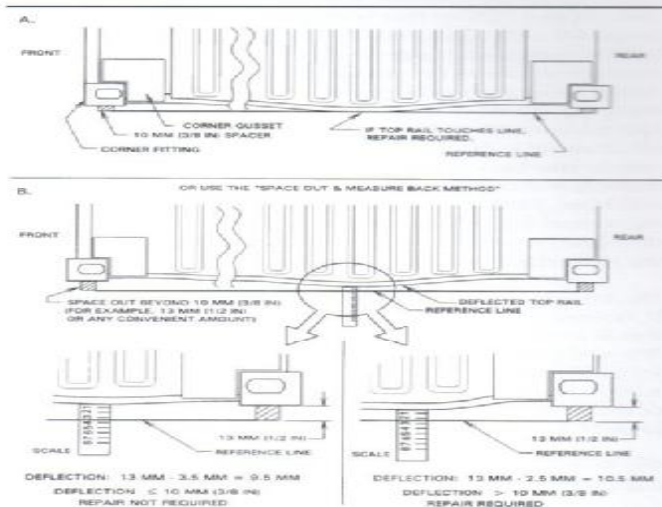
Fig. 4.2/Measuring outward bow in top rail. See Section 4.2.2.

Figure 4.2 illustrates a situation where a top side rail has an outward bow which the inspector suspects may exceed the IICL criteria for ISO dimensions and tolerances (ISO plus 10 mm [3/8 in]). In this case, the "space out" method must be used. The reference line is spaced out 10 mm (3/8 in) from the surfaces of the corner fittings; if the damage touches the reference line, the container is "out-of-ISO" and must be repaired (See Figure 4.2 A and Section 2.2).

over 10 mm (3/8 in) that places the reference line out beyond the damage, and can apply the "space out/measure back" method shown in Figure 4.2 B. In the example shown in this drawing, a reference line is positioned using spacers measuring 13 mm (1/2 in) in thickness, 3 mm (3/8 in) more than the IICL limit over ISO tolerances. In the situation illustrated on the bottom left drawing in Figure 4.2 B, a measurement from the reference line back to the point of maximum outward deflection shows more than 3 mm (1/8 in) between line and bow. Since the spacer thickness minus the measurement from the reference line to the point of maximum deflection is less than 10 mm (3/8 in), the bow is within the IICL plus ISO tolerances and repair is not required.

The bow in the drawing on the bottom right of Figure 4.2 B, however, does require repair: measurement reveals that less than 3 mm (1/8 in) remains between reference line and point of maximum bowing when a 13 mm (1/2 in) thick spacer is used. This means that the bow extends a little over IICL's 10 mm (3/8 in) limit beyond the surface of the corner fittings and therefore exceeds the IICL tolerance of 10 mm (3/8 in) beyond ISO.

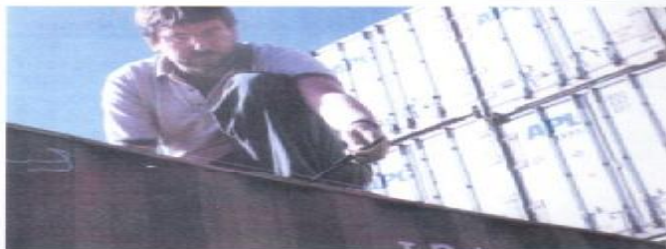
Measuring bows to rails: the inspector measures distance from reference line to point of maximum deflection in a flat-bar top side rail. In the case of bows, the reference line must be extended across the full length of the rail. See Section 4.2.3.

If there is bowing over the entire length of a side or end rail, the reference line must extend over the full length of the rail. When measuring bow deformation, do not forget to include any accompanying bend or dent depths in the measurement. See the bottom color photo on page 22.

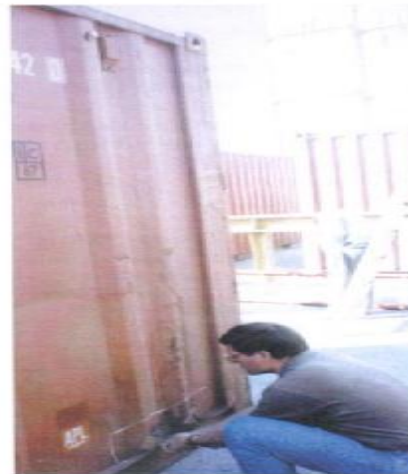
Measuring damage to side panels: the inspector measures a dent to a side panel impacted from outside. Note that the reference line extends vertically over the full height of the panel. See Sections 2.1.1, 4.4 and 4.4.1.

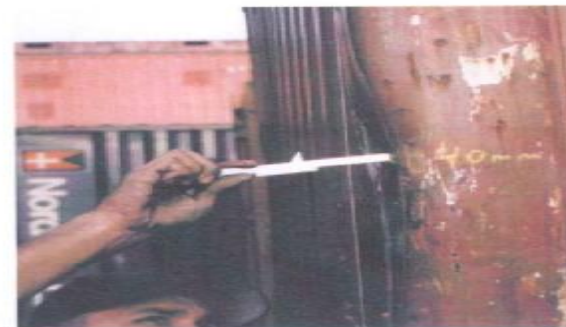
Measuring damage to corner posts: the inspector measures the distance from reference line to point of maximum deflection in a corner post bow. The reference line extends over the full height of the post. See Section 4.3.

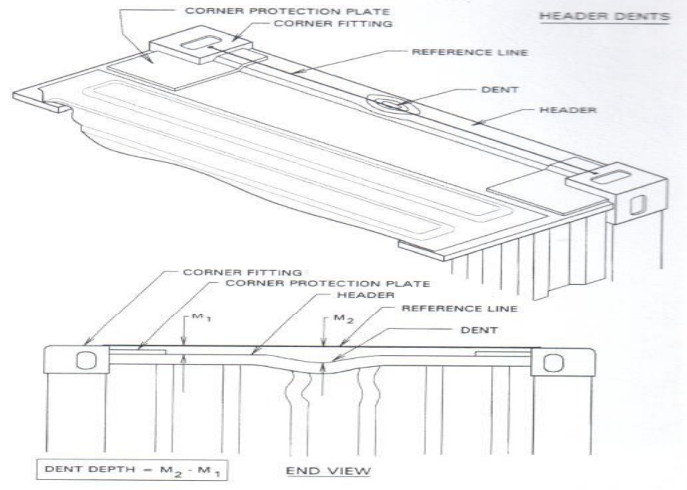
Fig. 4.3/Measuring damage to top header when corner protection plates prevent placing reference line over full length of header. See Section 4.2.4.

The location of the corner protection plates may prevent a reference line from being positioned over the full length of the header. In this case, the reference line may be placed on the corner protection plates where they overlap the header, and the damage depth ("D") is determined by subtracting the thickness of the corner protection plates from the measurement between reference line and point of maximum damage. The reference line may also be placed on the top surfaces of the corner fittings, as shown in Figure 4.3, and the depth of damage can be calculated using the "space out/measure back" method: the distance from rail to corner fitting top sur-

face is subtracted from the dimension between reference line and point of maximum damage.

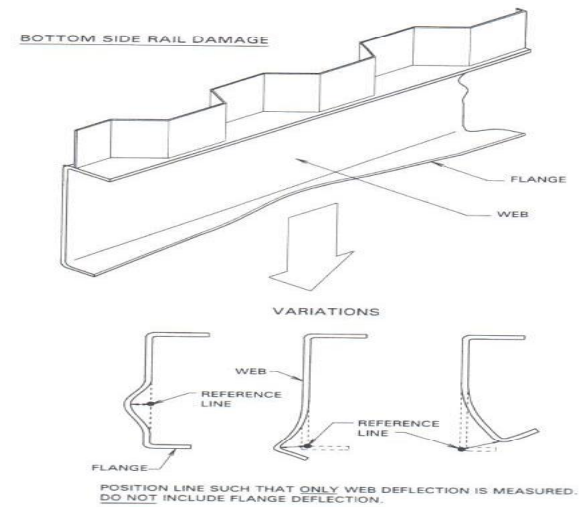
Fig. 4.4/Measuring damage to bottom rail web. See Section 4.2.5.

Figure 4.4 illustrates several different situations involving measurement of damage to bottom rail webs. Whenever possible, the reference line should be placed so that the damage extends away from the reference line and the maximum deflection of the web may be easily measured. If the flange is in the way and makes it impossible to measure the web deflection, use the method illustrated in Figure 4.28. Although the flange may be deflected, only damage to the web should be measured. Flange deflections should be ignored.

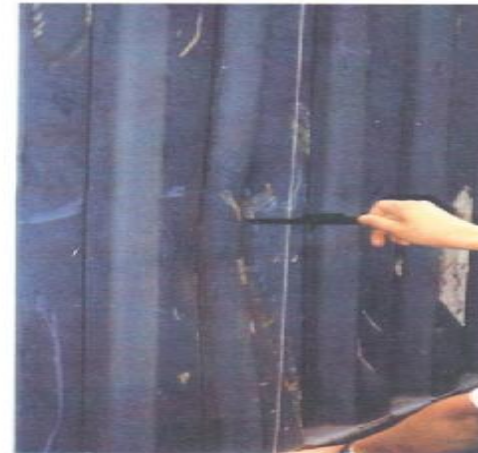
Measuring dents to side panels impacted from the outside: the inspector measures the distance from reference line to point of maximum inward deflection. Note that the reference line extends vertically over the full height of the panel. See Section 4.4.1.

As stated above, bends and dents in panels must be measured by extending the reference line vertically over the *entire height of the panel* from top to bottom, and making a measurement of the distance from the reference line to the point of maximum deflection, as shown in the photo on page 29. As explained in Section 2.1.1, the reference line must be placed directly over the point of maximum damage. Figure 4.7 illustrates this measurement method as applied to two common examples of panel damage. In these examples, the damage is from outside the container extending inwards. As mentioned in Section 4.3 above, the repairworthiness criterion is based on the depth of the dent or bend.

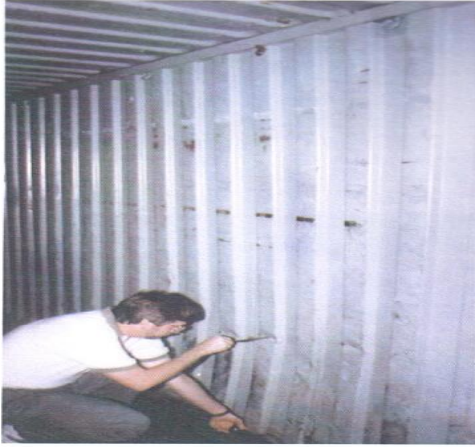
Measuring dents to panels impacted from the *inside*: the inspector inside the container measures the distance from reference line to point of maximum outward deflection. Note that the reference line extends vertically over the full height of the panel. See Section 4.4.2.

The same method as described above in Section 4.4.1 should be used to measure damage from the *inside* of the container extending *outwards*, as shown in the photo on page 30. In this case, however, both the depth limitation and also the ISO plus IICL tolerances must be considered. If damage extends beyond the ISO cube plus the additional IICL 10 mm (3/8 in) tolerance, it must be repaired. The procedure recommended by IICL for determining if the damage exceeds ISO plus IICL tolerances is illustrated in Figure 4.8, and is explained further in the following section.

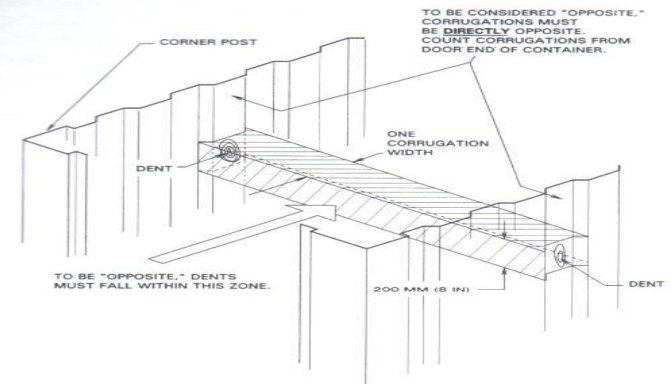
Fig. 4.9/Measuring opposite dents in side panels. See Section 4.4.4.

Figures 4.9 and 4.10 show how to measure opposite damage on panels. Each individual dent, bend or bow must be measured from the outside using the standard reference line methods for measuring damage to panels.

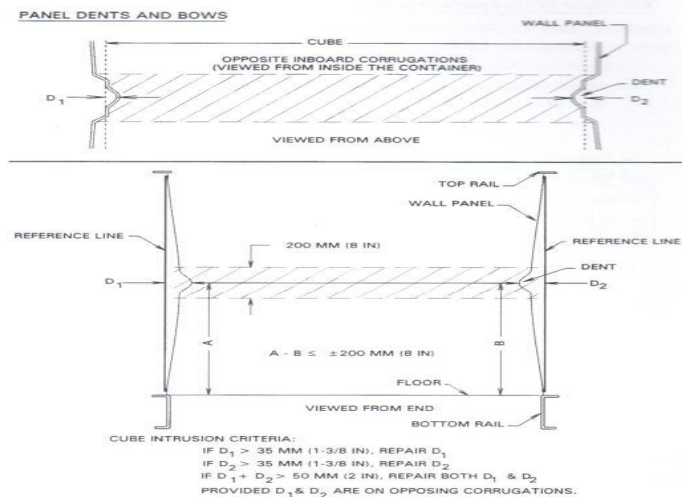
Fig. 4.10/Measuring opposite damage to determine if interior cube is reduced by more than 50 mm (2 in). See Section 4.4.4.

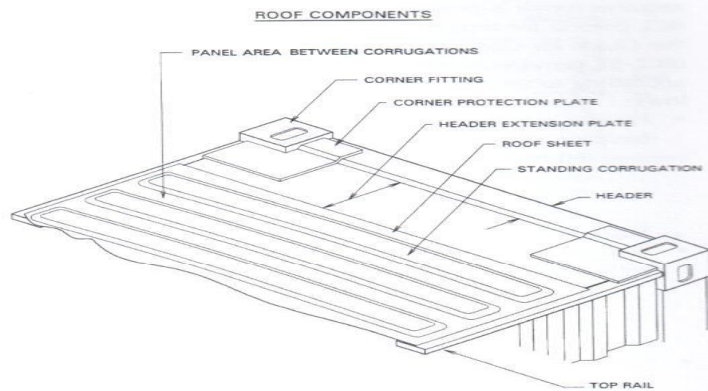
Fig 4.11/Location of container roof components. See Section 4.6.

The terms “header extension plate”, “standing corrugations” and the “panel area between corrugations”, which will be referred to throughout this section, are illustrated in Figure 4.11.

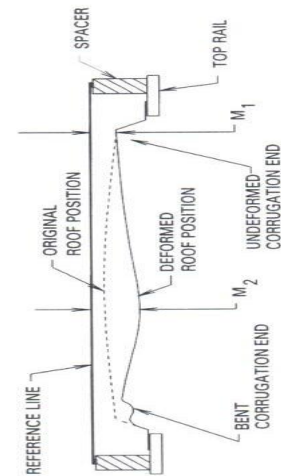
IF CORRUGATION END IS DAMAGED SO THAT REFERENCE LINE CANNOT BE PLACED ON CORRUGATION END, SPACE UP AND MEASURE BACK.

$$\text{DENT DEPTH} = M_2 - M_1$$

Fig 4.12/Measuring damage to roof panels when reference line cannot be placed on corrugations: spacers should be used. See Section 4.6.3.

In some cases, the end(s) of the corrugations will be damaged and therefore cannot be used to position the reference line. In this case, the reference line is spaced up from the top surfaces of the top side rails to clear the roof completely. The distance from the reference line to an undamaged corrugation end is measured just inside

the corrugation end radius. A second measurement is made from the reference line to the deepest point in the damage. The first measurement is then subtracted from the second to calculate the depth of damage. Figure 4.12 below describes this method.

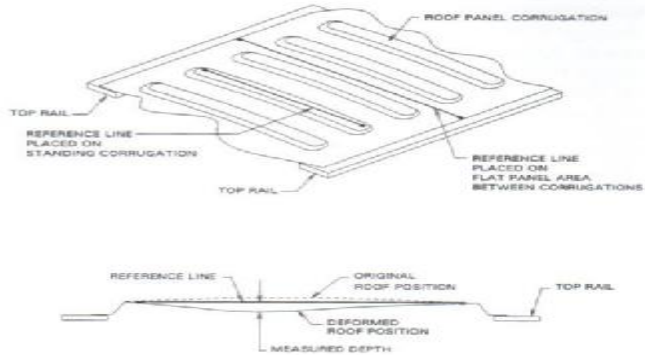
THE EFFECT OF ROOF CAMBER WILL BE NEGLECTED FOR THE PURPOSES OF MEASURING DOWNWARD ROOF BENDS. THEREFORE, STRETCH REFERENCE LINE OVER ENTIRE LENGTH OF CORRUGATION. IF DAMAGE IS IN FLAT AREA, STRETCH LINE ACROSS ROOF FROM RAIL TO RAIL.

Fig. 4.13/Measuring downward damage on roof panel standing corrugations and flat areas between corrugations. See Sections 4.6.1 and 4.6.2.

As stated in Section 2.1.2.2, this Guide recommends that roof camber (curvature) be ignored when measuring roof damage. In the case of downward damage on a standing roof corrugation, the damage depth is measured from the reference plane of the corrugation ends. The reference line is extended along the corrugation from just inside the radii at the tips of the formed ends of the corrugation. A measurement is then made of the distance from the reference line to the point of maximum downward deflection. Figure 4.13 and the top photo on page 41 illustrate this method.

Damage to the panel area between corrugations on a roof is measured as described in the section above, except that the reference line should be placed between the standing corrugations and extend across the roof from just inside the welds at either side of the roof sheet, as in Figure 4.13. The bottom photo on page 41 illustrates this method.

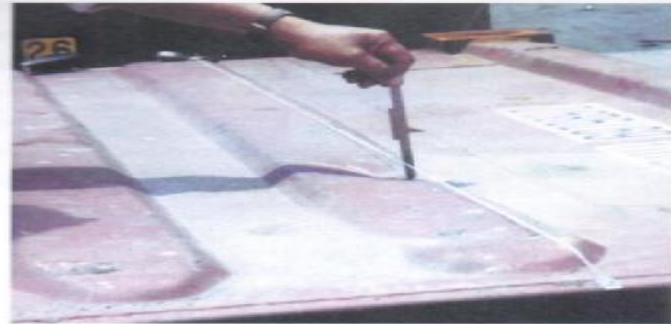
Measuring downward damage on a standing roof corrugation: the inspector measures the distance from reference line to point of maximum downward deflection. Note that the reference line extends along the corrugation across the full width of the roof. See Section 4.6.1.

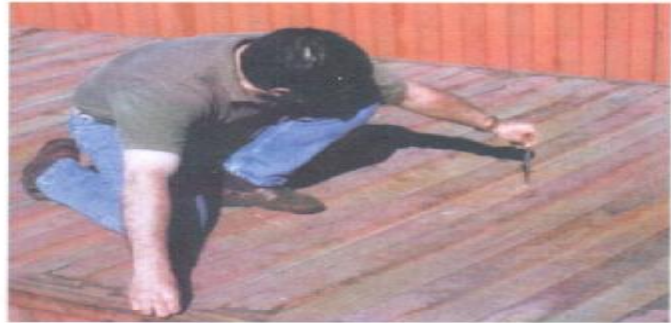
Measuring downward damage on the flat panel area between corrugations: the inspector measures the distance from reference line to point of maximum downward deflection. Note that the reference line has been placed on the flat panel area between corrugations, and extends across the full width of the roof. See Section 4.6.2.

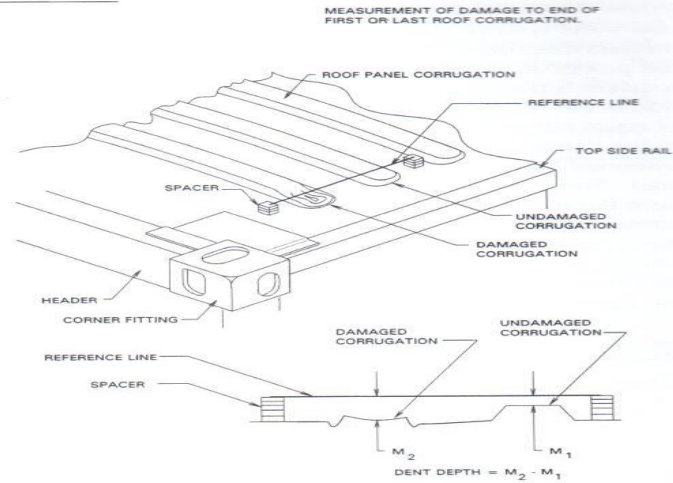
Fig. 4.15/Measuring damage to standing corrugation at roof ends, when end of last corrugation is damaged. See Section 4.6.4.

When the end of the last corrugation on either end of a roof sheet is damaged, it is not possible to use the method described above in Section 4.6.3. In this case, the procedure illustrated in Figure 4.15 is recommended: a spacer is placed on the flat panel area on the opposite side of the nearest undamaged corrugation, and a spacer of equal height is placed on the flat panel area adjacent to the damaged corrugation. The reference line is extended between the two spacers over the damaged area. The inspector should first measure the distance from the reference line to the undamaged corrugation (shown as dimension "M₁" in Figure 4.15), and then from the reference line to the point of maximum damage (shown as dimension "M₂" in Figure 4.15). The first measurement is subtracted from the second to calculate the depth of damage.

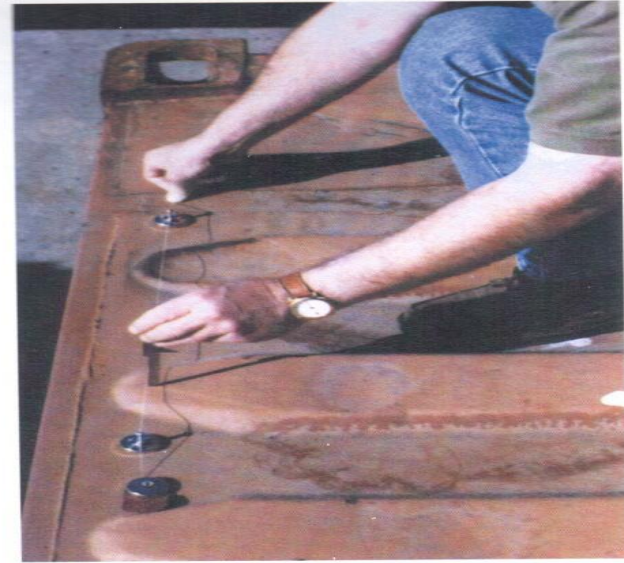
Measuring downward damage on a standing corrugation end at roof ends, Step #1: one spacer has been placed on the flat panel area on the opposite side of the nearest undamaged corrugation, and another on the flat panel area next to the damaged corrugation. A reference line has been extended between the two spacers (the two round objects just below the inspector's hands); each spacer has a protruding vertical pin to hold the reference line over the corrugations). The inspector is measuring the distance from reference line to the surface of the undamaged corrugation to establish a reference plane. See Section 4.6.4.

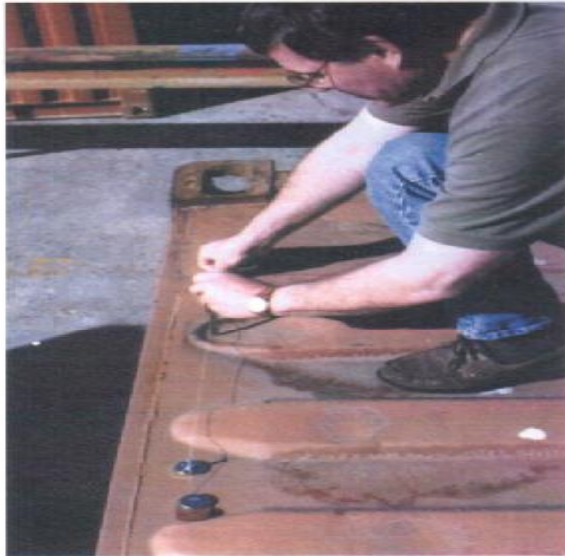
Measuring downward damage on a standing roof corrugation end at roof ends, Step #2: the inspector measures the distance from reference line to point of downward maximum deflection. To calculate the depth of damage, the first measurement made in Step #1 is subtracted from the second measurement made in Step #2. See Section 4.6.4.
