Box repair and surveys

General repair procedures

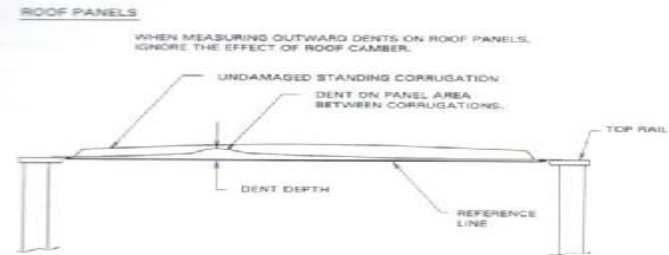
Fig. 4.16/Measuring upward damage on roof panels between corrugations. See Section 4.6.5.

When measuring upward damage to roofs, roof camber (curvature) should be ignored, as has been recommended above in Sections 2.1.2.2 and 4.6.1 above. In this case, the measurements are made from within the container. The reference line should be extended across the roof width from just inside the top side rails on either side of the damage, and dent depth measured from the refer-

ence line to the point of maximum upward deflection. Figure 4.16 below illustrates this method.

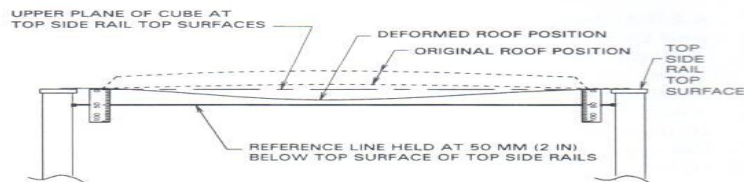
Fig. 4.19/Measuring downward bow of roof sheet (flat-bar rail). See Section 4.6.7.2.

If the top rail is a flat-bar type, a reference line is spaced downward from the top surface of the side rails 50 mm (2 in). If the roof sheet touches the reference line, repair is required. Figure 4.19 illustrates this method.

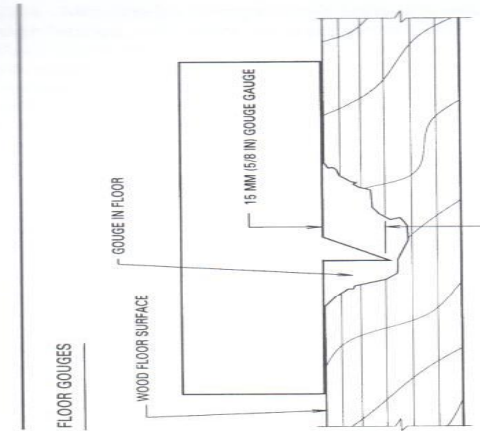
Fig. 4.20/Measuring floor gouge for depth only, using a gouge gauge. See Section 4.7.1.

Alternatively, the inspector can use a type of scale with a 15 mm (5/8 in) protrusion, as shown in Figure 4.20 opposite. If the protrusion does not touch the bottom of the gouge, repair is required.

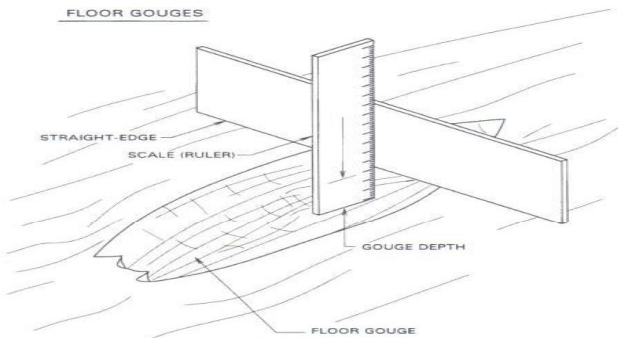
Fig. 4.21/Measuring floor gouge for depth only, using a straight-edge and a scale (ruler). See Section 4.7.1.

In the first case, a straight-edge is placed horizontally on edge across the gouge to establish the position of the undamaged floor surface. A scale or ruler is used to measure the distance from the straight-edge to the bottom of the gouge. The same basic approach is used to measure height differences between planks. This method is shown in Figure 4.21 opposite.

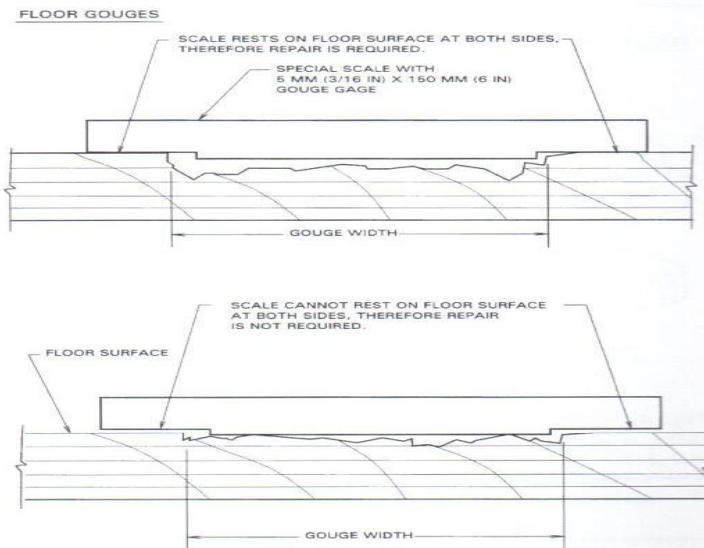
Fig. 4.24/Measuring floor gouge for depth *and* width, using a special scale (ruler). See Section 4.7.2.2.

The depth and width of a gouge can also be measured using a special scale that is designed with a 150 mm (6 in) by 5 mm (3/16 in) protrusion on one side. The scale is placed across the gouge with the protrusion face down in the gouge and perpendicular to the gouge length. If the ends of the scale beyond the protrusion on either side rest firmly on the undamaged floor surfaces on either side of the gouge, the gouge must be repaired. If the ends of the scale on either side of the gouge do not touch the floor (*i.e.*, if there is space between the bottom edges of the scale and the undamaged floor), the gouge does not require repair. This method is illustrated in Figure 4.24.

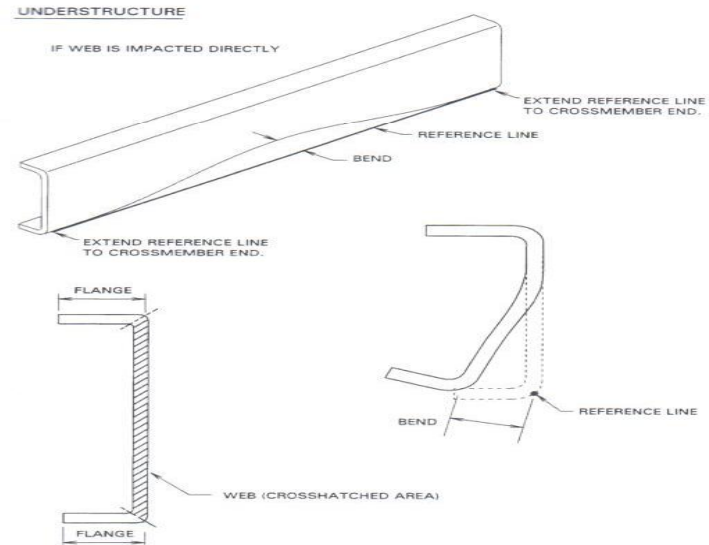
Fig. 4.25/Measuring damage to crossmember web when impacted directly. See Section 4.8.1.

Figure 4.25 shows a common type of crossmember web damage in which the web has been damaged by a direct impact. In this case, a reference line is extended over the crossmember from one side rail to the other, outside the points of attachment of the formed edge between web and flange. The distance between the reference line and the point of maximum deflection is measured to determine if the web requires repair. Figure 4.25 on page 55 and the photos on page 57 opposite illustrate this method.

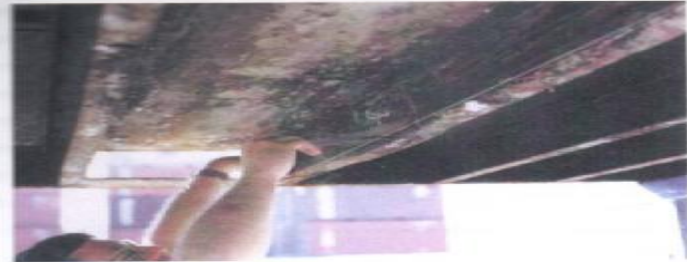
Measuring direct impact to crossmember web: the inspector measures the distance from reference line to point of maximum deflection in the web. Note that the reference line extends across the full width of the crossmember along the formed edge between web and flange. See Section 4.8.1.

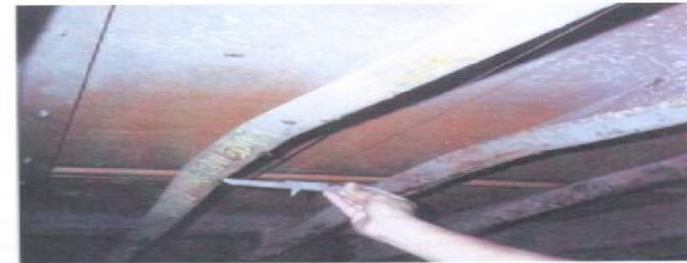
Measuring direct impact to crossmember web: as in the photo on the top of the page, the inspector has extended the reference line along the full width of the crossmember from rail to rail, and is measuring the distance from reference line to maximum point of the web deflection. See Section 4.8.1.

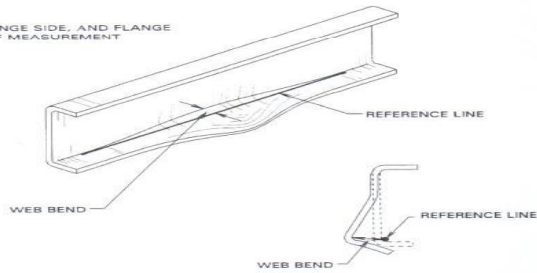
Fig. 4.26/Measuring damage to crossmember web when flange side has been impacted. See Section 4.8.2.

IF BENT FROM FLANGE SIDE, AND FLANGE IS NOT IN PATH OF MEASUREMENT

Figure 4.26 shows another common type of crossmember web damage. In this case, the web has received an impact from the flange side of the crossmember. The reference line is extended from one side rail to the other along the *inside radius* of the crossmember where the web meets the flange, as shown in Figure 4.26. A measurement is then made from the reference line to the point of maximum deflection in the web. This is the preferred method of measurement.

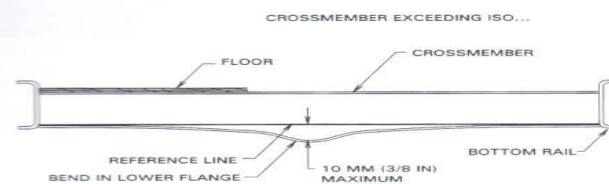
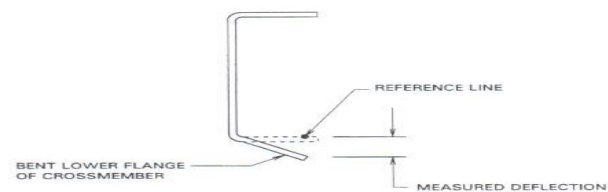
Fig. 4.30/Measuring crossmember damage to determine if ISO + IICL tolerances are exceeded. See Section 4.8.3.

IF CROSSMEMBER IS BOWED OR CROSSMEMBER LOWER FLANGE IS BENT SUCH THAT IT IS MORE THAN 10 MM (3/8 IN) BELOW ITS ORIGINAL POSITION, REPAIR IS REQUIRED.

Measure the distance from the line to the lowest point of the top surface of the lower flange. If this distance is greater than 10 mm (3/8 in), repair is required. See Figure 4.30.
